DEPARTMENT OF TOXIC SUBSTANCES CONTROL1011 N. GRANDVIEW AVENUE
GLENDALE, CA 91201
(415) 551-2800

INSPECTION REPORTQuemetco Inc.
720 South 7th Avenue
City of Industry, CA 91748

EPA ID # CAD066233966

Date of Inspection: June 23, 1993

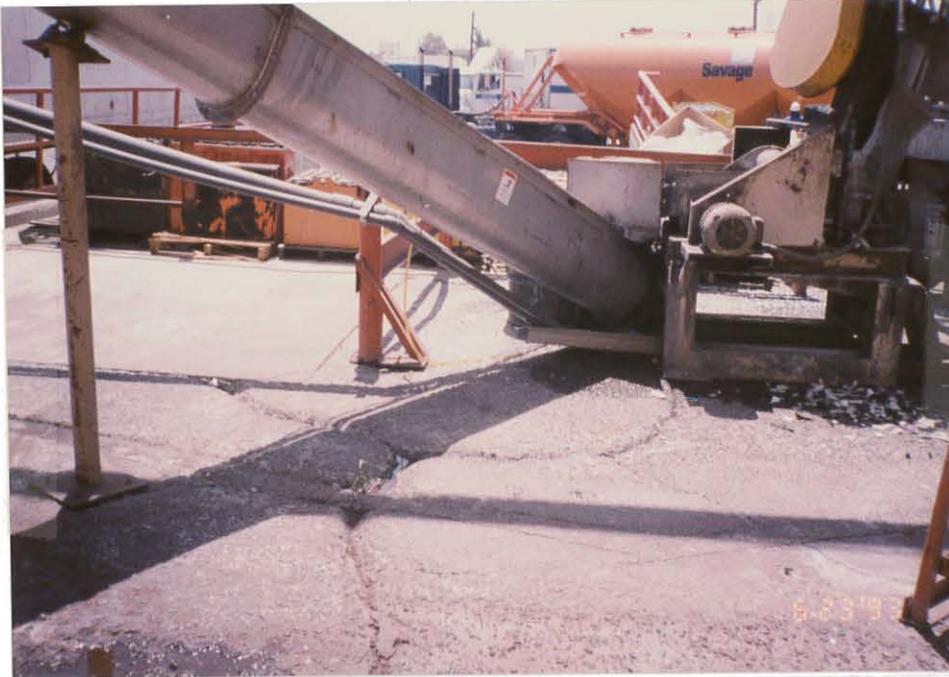
Photo No.: 1 Date: June 23, 1993 Inspector: G. Hernandez

Description Photo of battery conveyor belt, showing the cracks on the asphalt. Photo taken by Chiang.

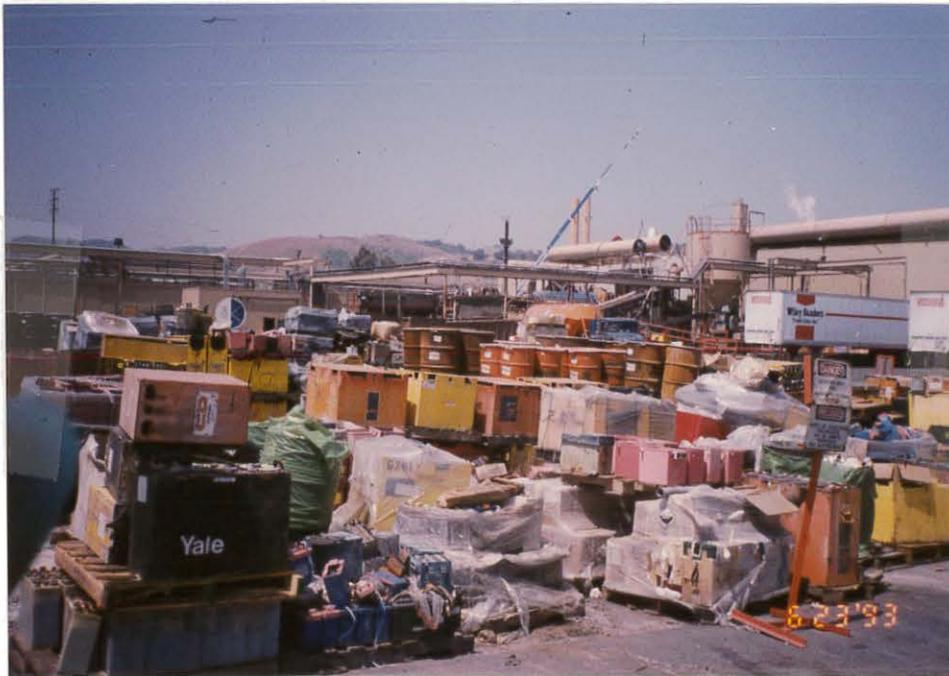
Photo No.: 2 Date: June 23, 1993 Inspector: G. Hernandez

crusher, batteries are staged here until a later date. I informed Vondersaar that I observed that the asphalt covered area had several cracks and that I had a concern with materials leaking onto the soil (See Attachment A, Photo # 2). He stated that a full time staff person goes around every week to repair all the cracks in the facility. He added that asphalt breaks easily due to heavy equipment traffic and that acids are able to break up the concrete. Currently Quemetco is testing a new material to be used as a patch in the scale house and it seems to be holding up well.

Description Photo of a Battery Staging Area. Photo taken by Chiang.

1. Hazardous waste label placed on the 55 gal. drum containing oily rags did not indicate the hazardous characteristic of the waste. This was corrected on 6/23/93 by indicating the "TOXIC" property on the label
2. Cracks observed in the battery storage area have been sealed.
3. We are in the process of obtaining bids to repair concrete erosion in the battery cracking area.
4. The two roll-off boxes containing used bricks had hazardous waste labels which did not indicate the hazardous characteristic of the waste. This was corrected on 6/23/93 by indicating the "TOXIC" property on the label.

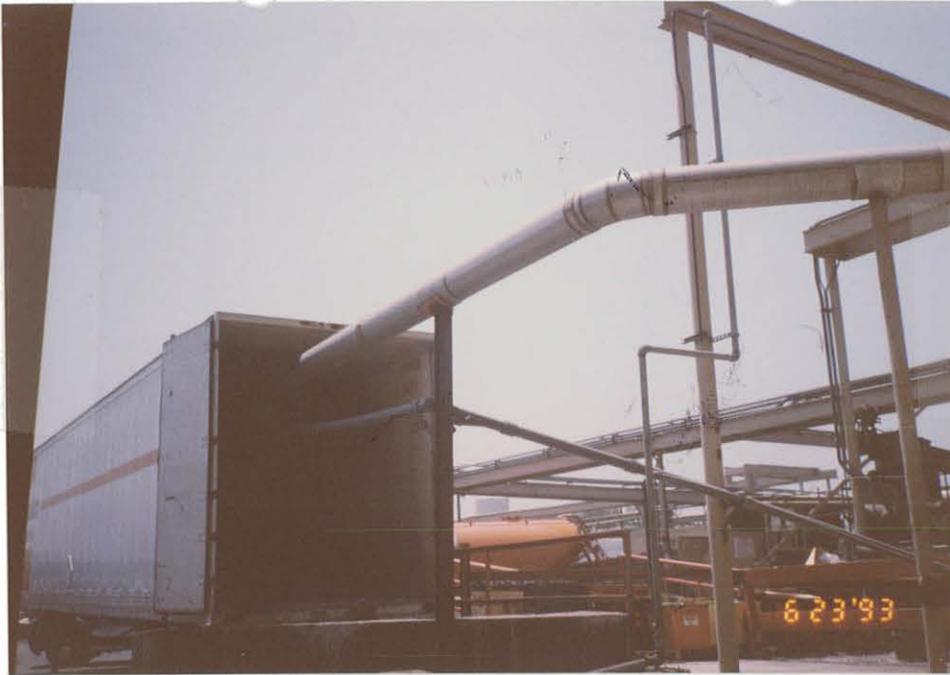
Photo No.: 3 Date: June 23, 1993 Inspector: G. Hernandez

Description Photo of polypropylene chips going from the blower system into the trailers. Photo taken by Chiang.

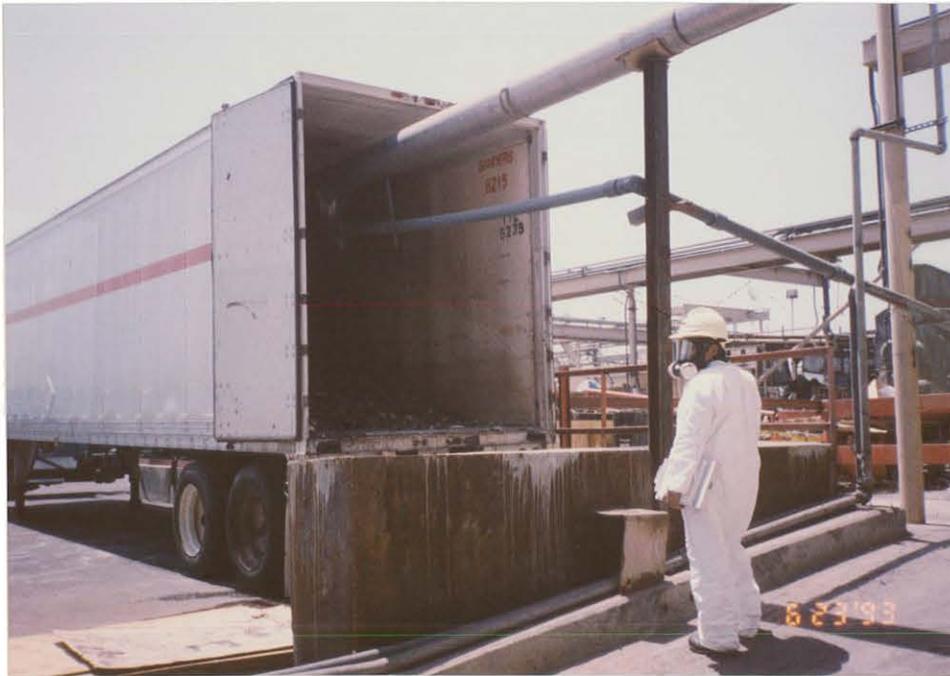
Photo No.: 4 Date: June 23, 1993 Inspector: G. Hernandez

Description Photo of polypropylene chips going from the blower system into the trailers. Photo taken by Chiang.

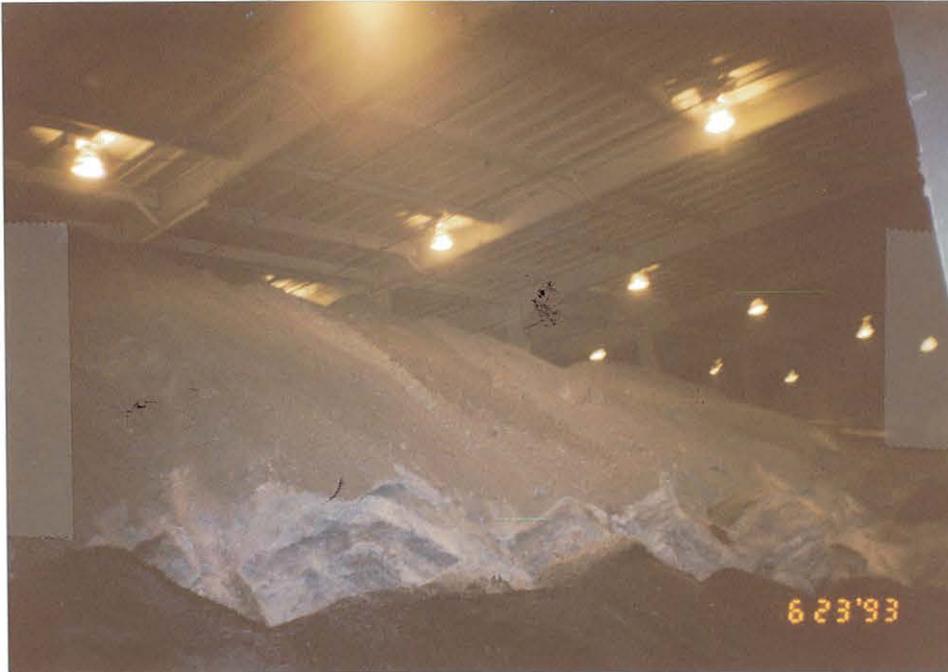
Photo No.: 5 Date: June 23, 1993 Inspector: G. Hernandez

At the Batch House (See Attachment A, Pictures # 5 & 6) we observed the storage of all the waste piles. Vondersaar informed us that as of May 1993, second run slags are no longer shipped to their sister facility in Indianapolis.

Description Photo of batch house, where the waste piles are stored. Photo taken by Chiang.

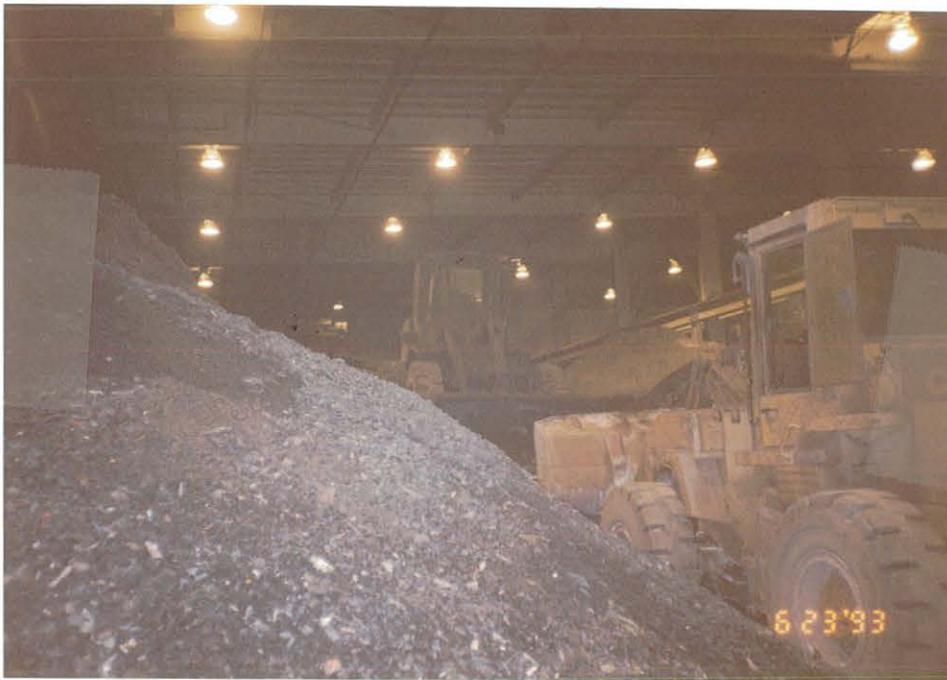
Photo No.: 6 Date: June 23, 1993 Inspector: G. Hernandez

Description Photo of batch house, where waste piles are stored. Photo taken by Chiang.
