**FINAL  
SITE INSPECTION WORK PLAN**

**Upper Burning Ground  
Sierra Army Depot  
Herlong, California**

**April 2007**

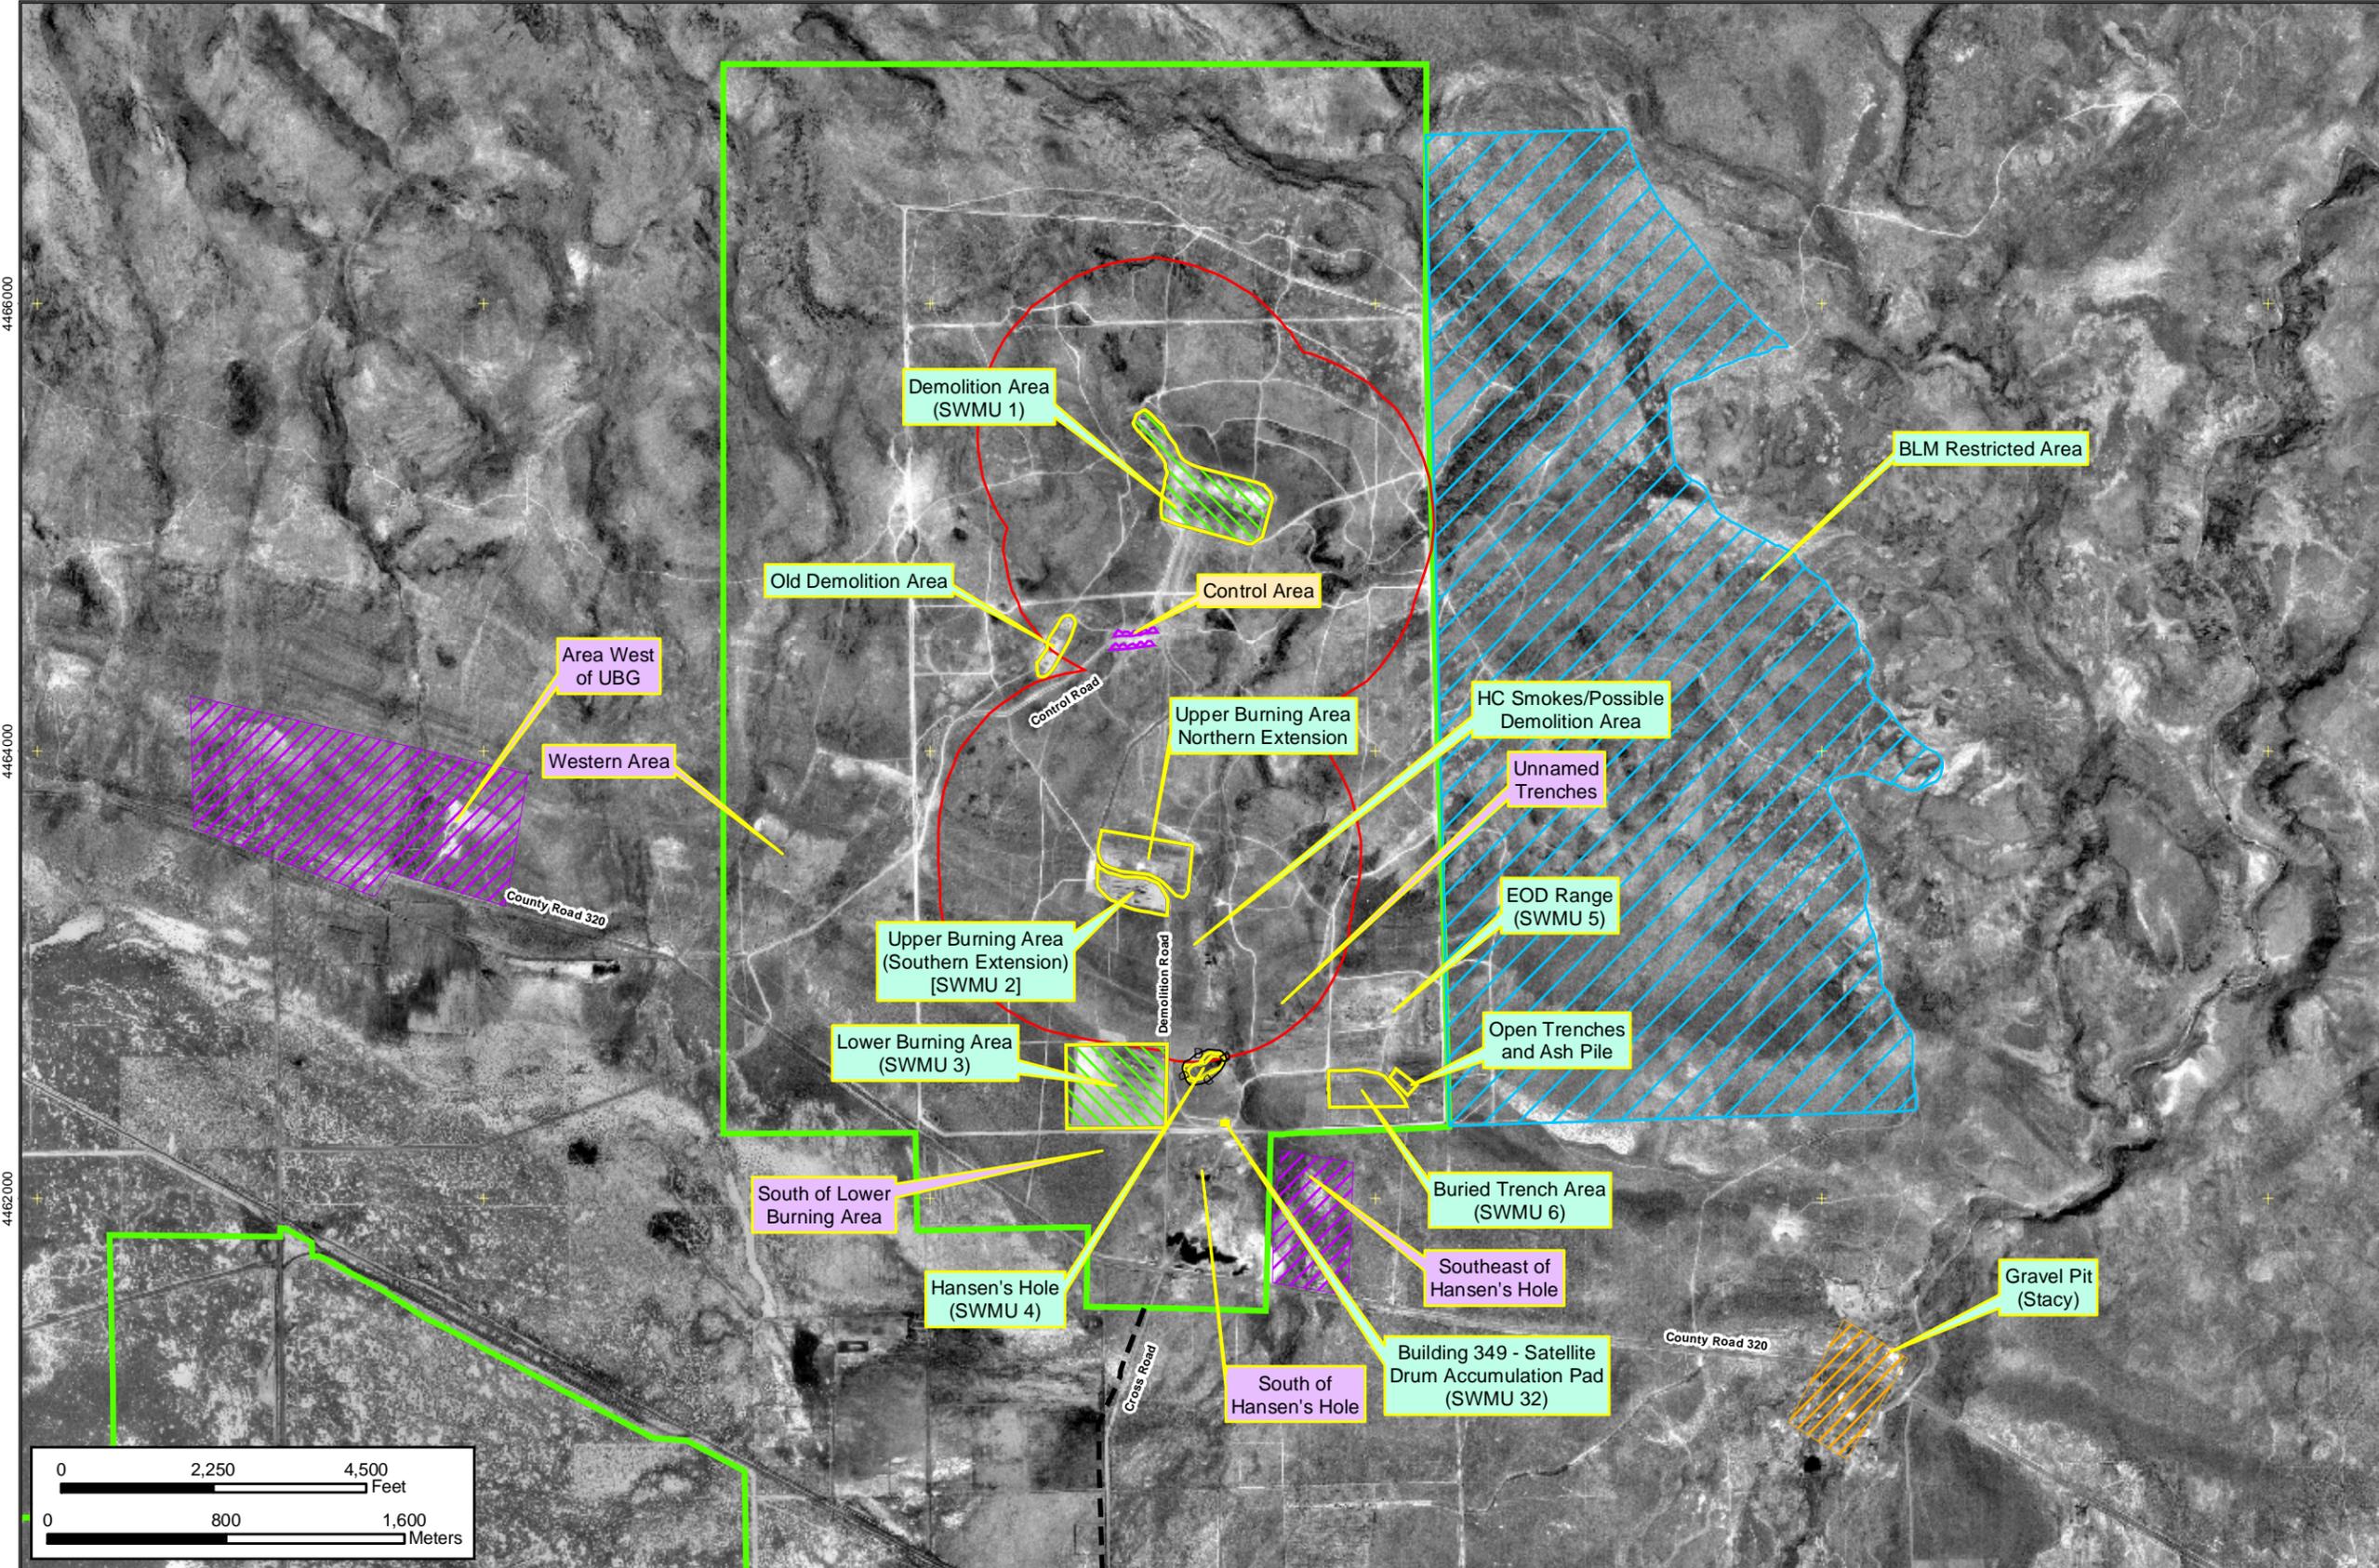
Figure 2-3  
Areas of Interest

Numerous Areas of Interest (AOIs) were identified in and around the UBG. A list of the AOIs identified and discussed in the HRR is provided in Table 2-2 and depicted on Figure 2-3. Based on information collected for the HRR, several of the AOIs were determined to be ineligible for the MMRP. Two of the AOIs, the Demolition Area and the Lower Burning Area, are RCRA sites that are being addressed under a RCRA Closure Plan. Several other areas were either partially or completely addressed under the Installation Restoration Program (IRP). Table 2-2 provides the MR eligibility determination for each AOI. Those that were determined to be ineligible will not be discussed further in this report. Detailed information regarding the ineligible sites is provided in the HRR.

The Upper Burning Area is divided by Demolition Road into the Northern and Southern Extensions and is located to the south and downslope from the Demolition Area and southeast of the Old Demolition Area. The Northern Extension consists of approximately 30 acres bordered on the west and south by the paved Demolition Road. The Southern Extension encompasses 12 acres and is bordered on the east and north by Demolition Road. Refer to Figure 2-3 for the site location.

TEC completed an analysis of aerial photographs of the UBG from 1949 to 1990 and the text below provides a description of the sites identified and approximate dates (Figure 2-3). Some of the areas noted are actually located outside of the UBG, to the west, between the UBG and a gravel pit. These significant areas will be investigated in the course of field activities. Although the aerial photographs do depict the AIOs identified in Section 2.1, they are not discussed below, as they are included with the site specific text provided in Section 2.1.

**Western Area** – Beginning in 1954, there is evidence of ground scarring, berms, and a possible pit near the western boundary of the UBG, roughly parallel with the Upper Burning Area. It was noted by TEC that this area might have been used as a gravel pit. In the 1970s, the area of disturbance expanded and TEC indicated that the disturbance was caused by excavation. By 1984, the boundaries for the areas of disturbance previously identified on the 1970 photograph had changed. The areas previously described as being caused by excavation appear smaller and areas identified as linear features and ground scars have been added. The ground still appears to be disturbed in 1990 (Figure 2-3).

**HC Smokes/Possible Demolition Area** – There are areas identified on aerial photographs as a possible impact crater, a berm, and a trench located east of the Upper Burning Area and north of Hansen's Hole. A figure from 1951 indicates that the area near these disturbances was a proposed demolition area. No records were located indicating whether the proposed demolition area was completed. The ground disturbance is still present. TEC indicated that it might have been caused by excavation. The 1970 photograph reflects three dark colored linear features in this area. These features are currently of unknown origin. The ground scars are still visible in 1984 (Figure 2-3).

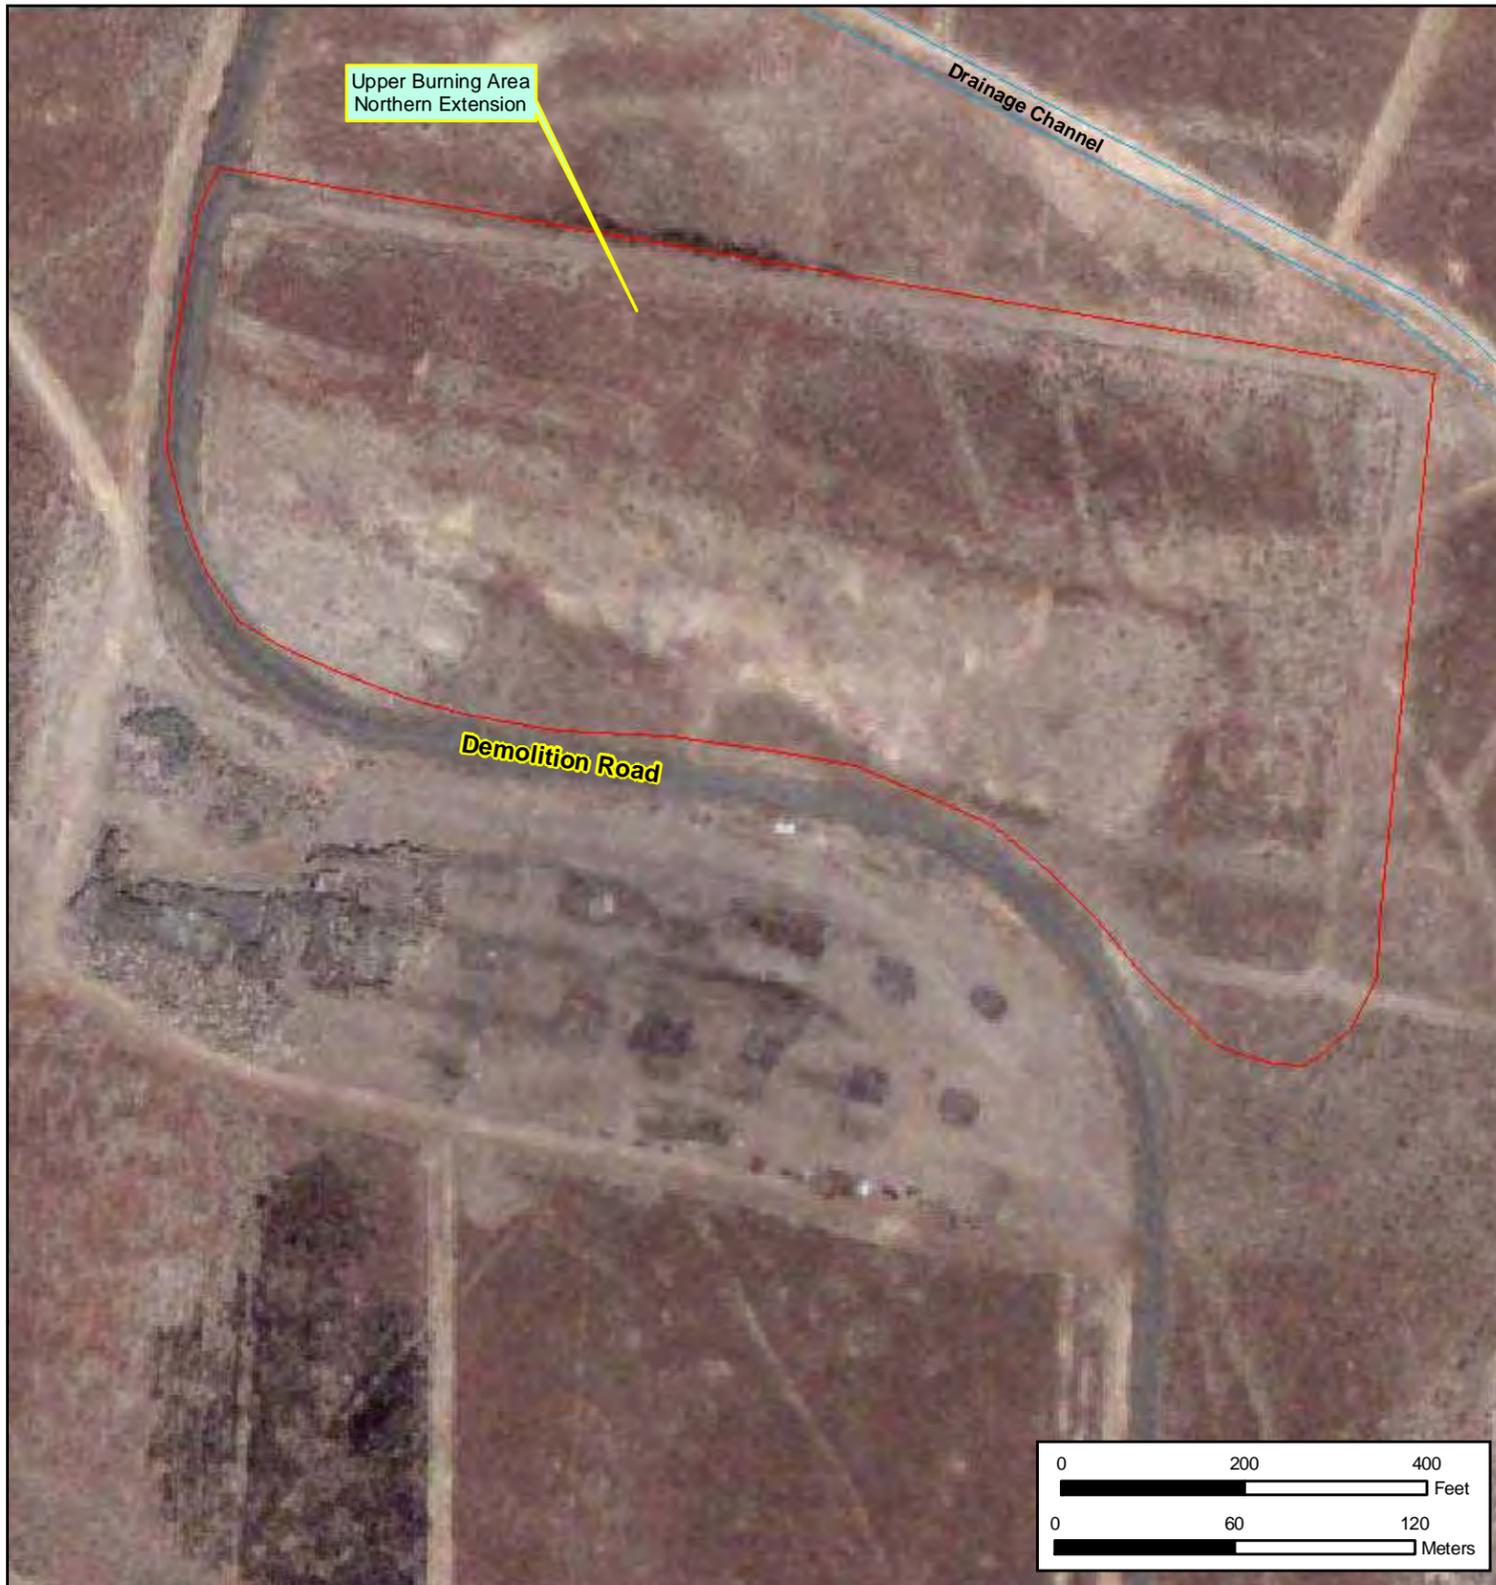
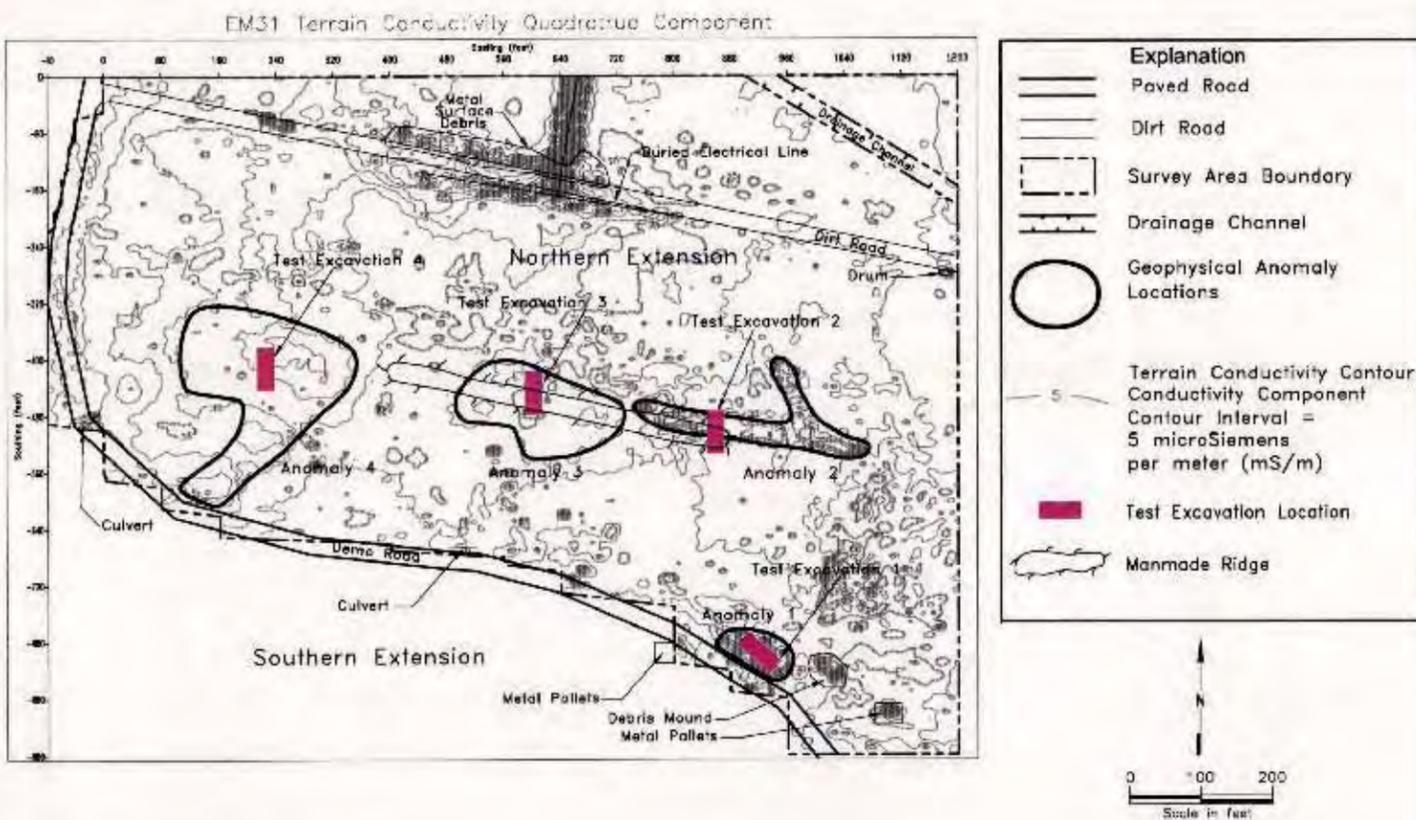
**Figure 2-4  
Previous  
Investigations at the  
Upper Burning  
Area Northern  
Extension**

Geophysical Data for the  
Upper Burning Area Northern Extension  
provided by Mactec
