PRELIMINARY ENVIRONMENTAL ASSESSMENT REPORT

**Autumnwood Development
Amaryllis Court, Wildomar, California 92595**

September 27, 2012

Project No. Swanson.p01

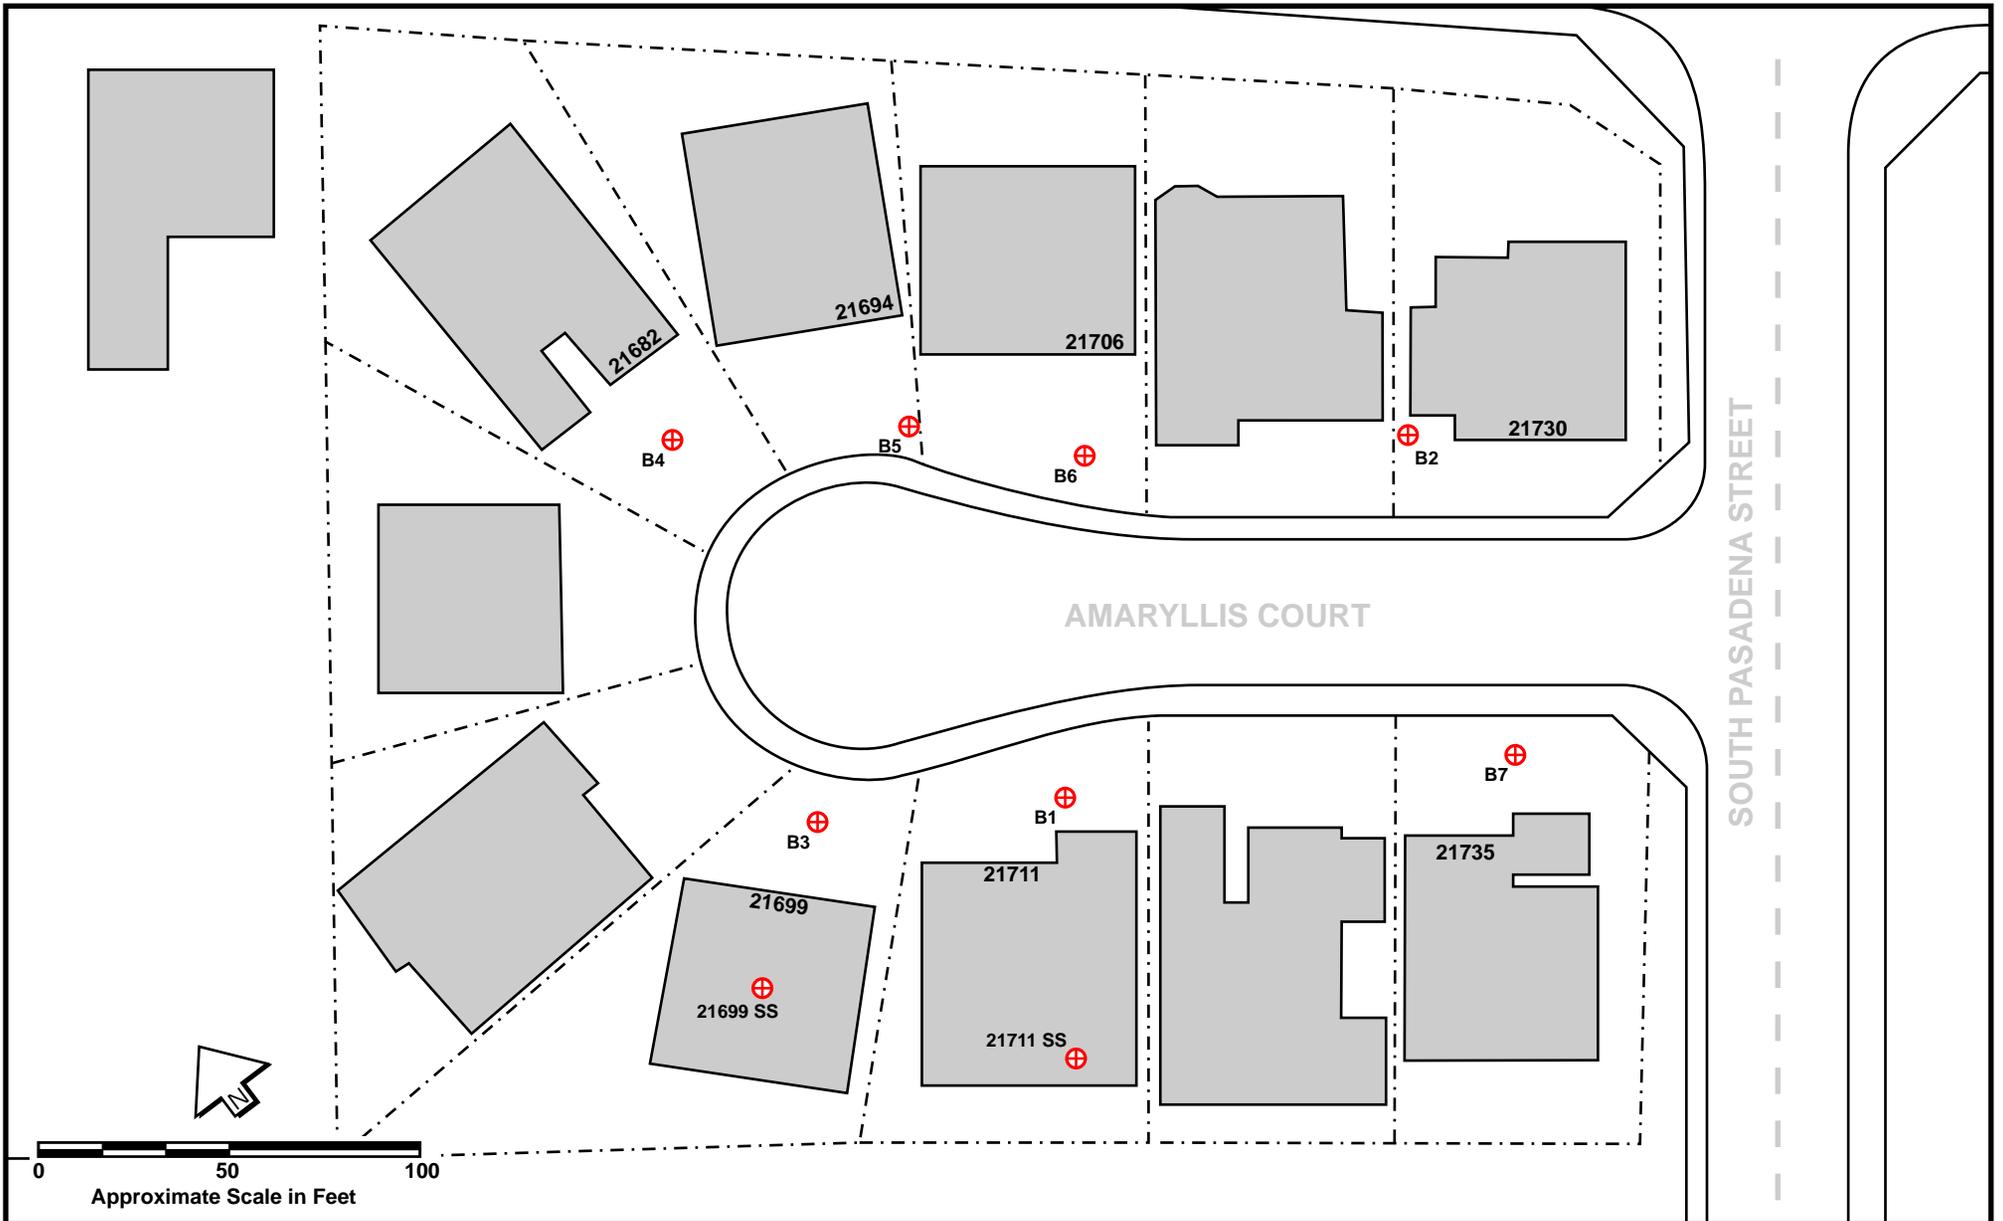
- B1 - B7 ⊕ Soil boring/soil-gas probe
- 21711 SS ⊕ Sub-slab soil-gas sample

The boring locations were selected in areas to coincide with areas where VOCs were previously identified as well as areas outside the previously investigated areas to evaluate background soil and soil-gas conditions. The soil boring locations are shown on Figures 2 and 3 and indicate the general areas where the borings were located, based on field conditions and clearance in those areas.

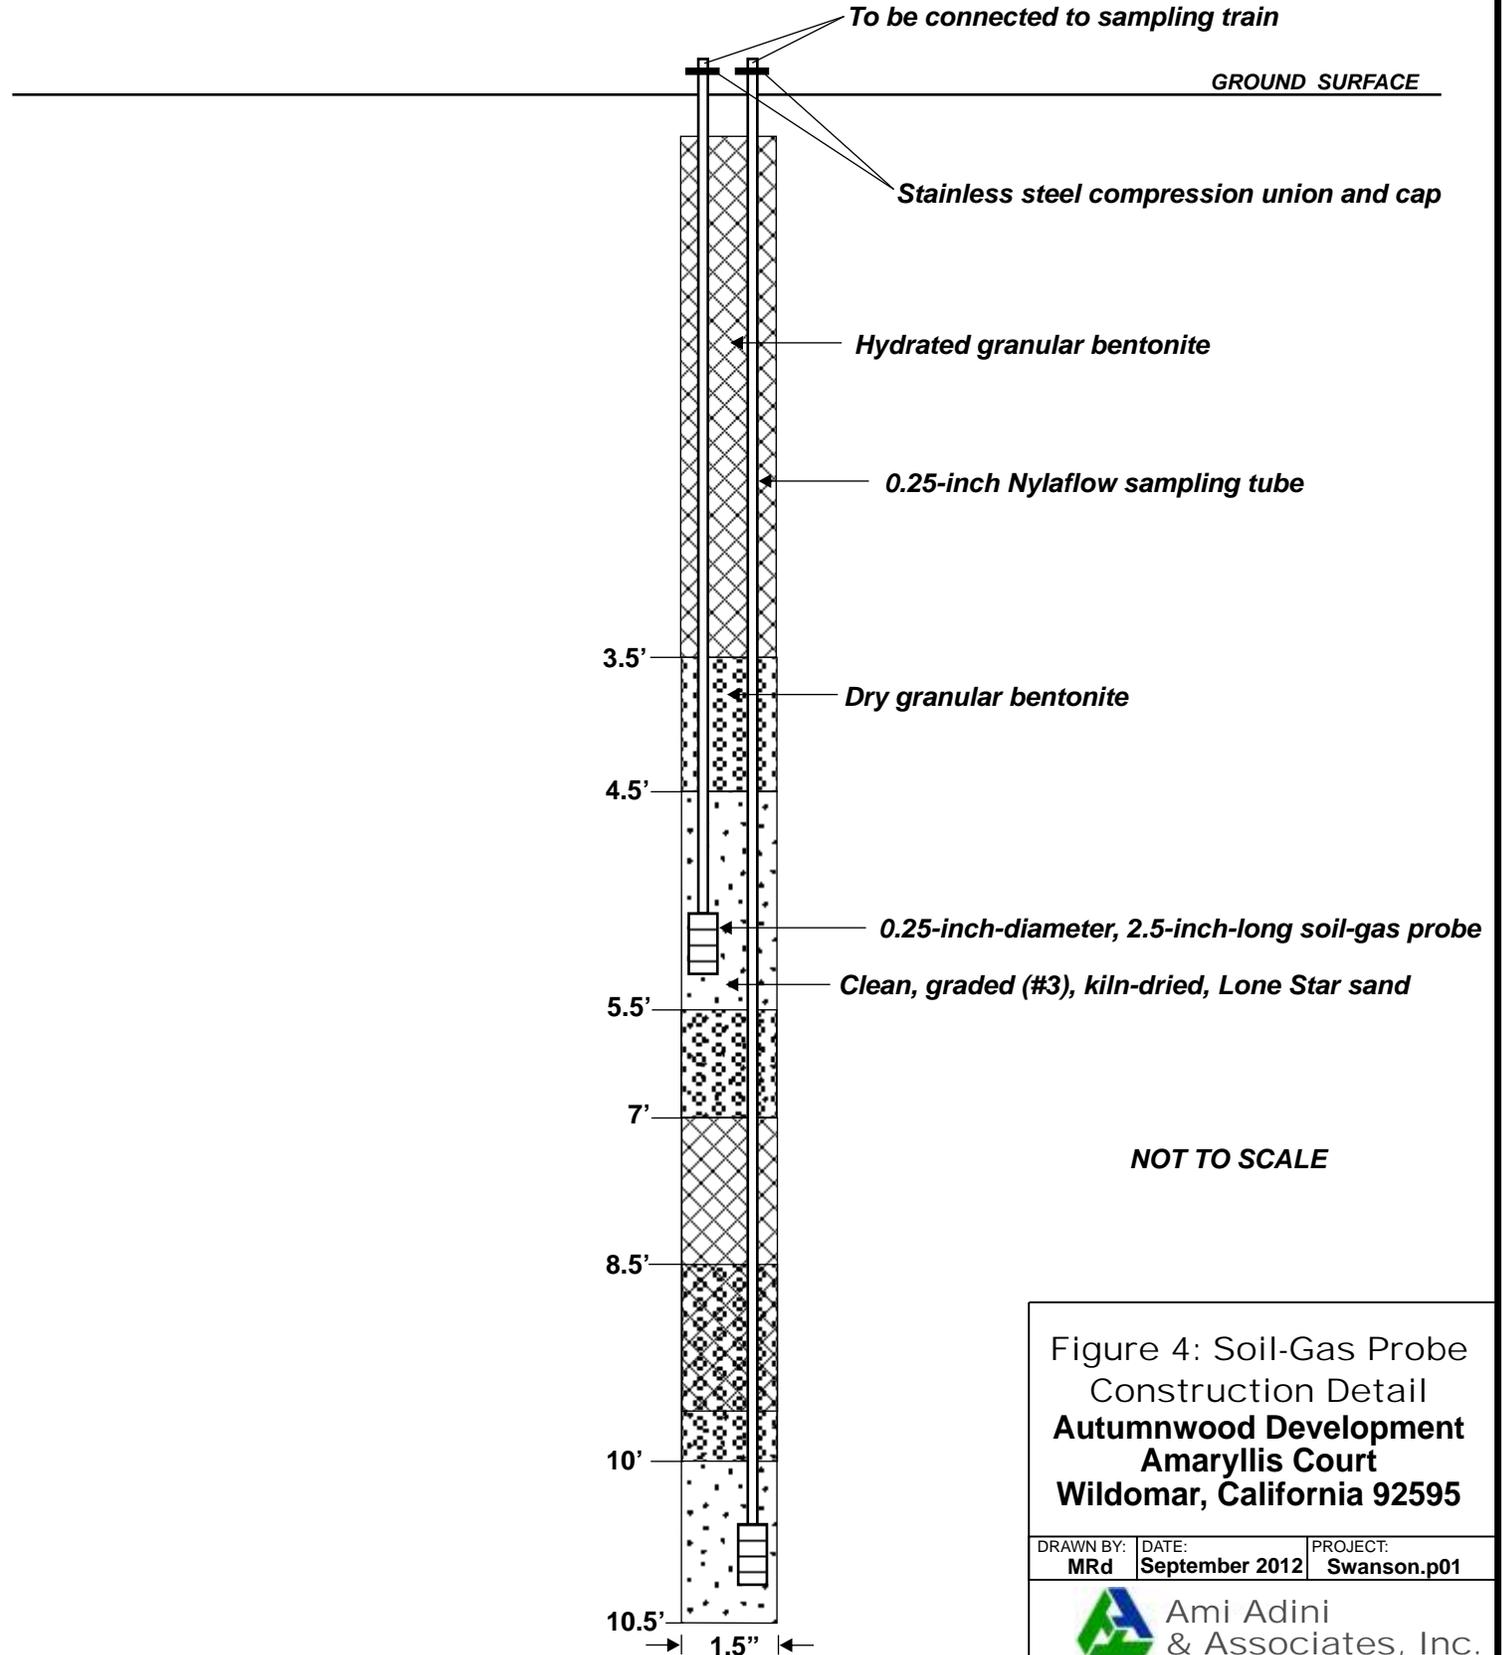
Figure 4: Soil-Gas Probe Construction Detail
Autumnwood Development
Amaryllis Court
Wildomar, California 92595

Soil-Gas Probe Construction Diagram B1 to B7

The soil-gas probe installation, leak testing procedures, determination of purge time/volumes, purge rates, and sample collection methodologies were conducted in general accordance with Cal/EPA's *Advisory – Active Soil Gas Investigation* (Cal/EPA, 2012). The soil-gas sampling and analysis was completed by Jones Environmental, Inc., of Fullerton, California. The soil-gas probe locations coincided with the soil boring locations and are shown on Figure 2.

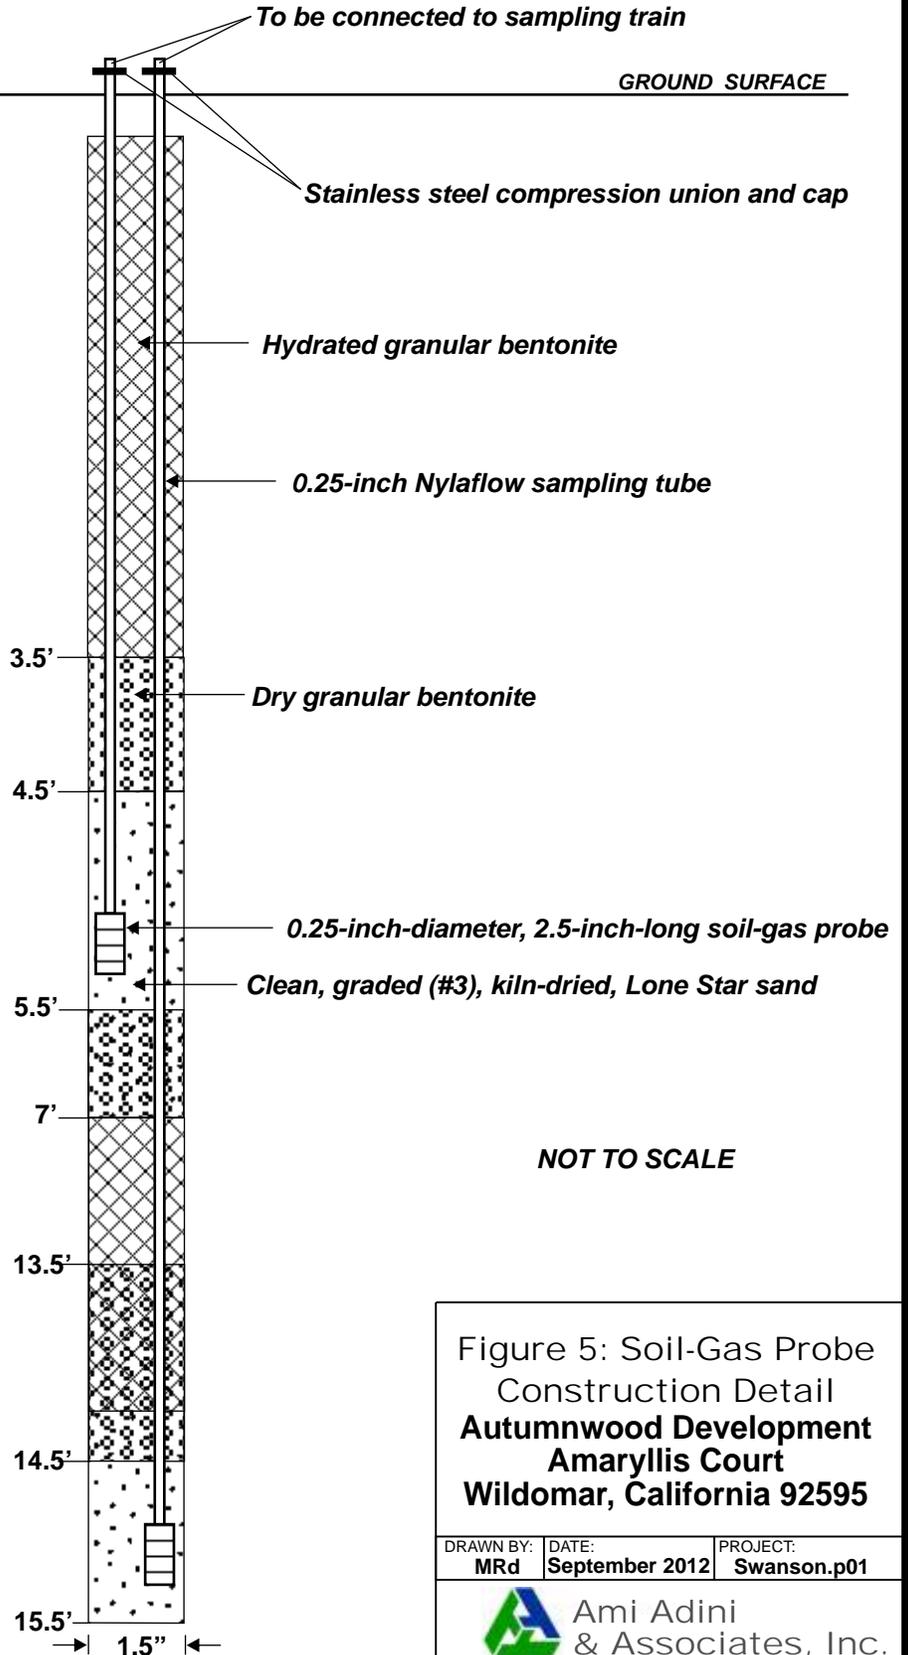
Figure 5: Soil-Gas Probe Construction Detail
Autumnwood Development
Amaryllis Court
Wildomar, California 92595

Soil-Gas Probe Construction Diagram B1b

On September 12, 2012, AA&A advanced seven soil borings (B1 through B7) and installed two soil-gas probes in each boring at depths of 5 and 10 feet bgs. A second boring (B1b) was installed in the vicinity of boring B1 so that soil-gas probes could be installed at 5 and 15 feet bgs. The second 5 foot soil-gas probe was installed at the B1b location as the 5 foot probe installed at the B1 location did not produce any volume of soil-gas at the initial time of sampling. The blockage of soil-gas from the soil-gas probe may have been caused by the probe tubing collapsing during construction of the probe or the probe tip being overly saturated by soil moisture. The locations of the borings are shown on Figure 2. The locations of the soil-gas probes were selected in the field and were located primarily in the areas where previous assessment activities warranted additional investigation. AA&A selected these locations to evaluate subsurface conditions in areas where elevated concentrations of contaminants had been reported in sub-slab soil-gas and/or indoor air samples.

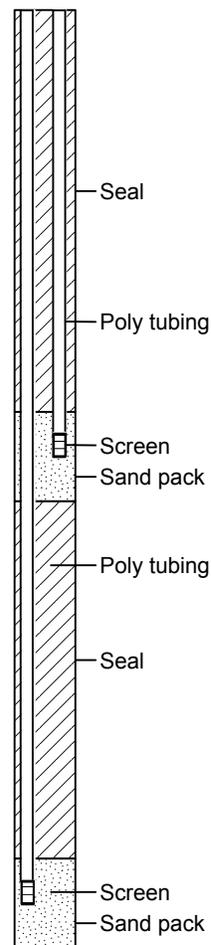
Depth in Feet	Surface Elevation	Sample Identification Number	USCS	GRAPHIC	Sample Condition	OVA/PID READING (ppm)	Sample Condition	Blow Count Recovery Interval	Well: B1 TOC Elev.:
					<input type="checkbox"/> Disturbed <input type="checkbox"/> Continuous Core (undisturbed) <input type="checkbox"/> No Recovery				
0			SW		Grass surface. Hand-augered to 4 feet below ground surface (bgs).				
		B1-3	SW		SAND, well graded, dark brown (10YR3/3), moist, non-plastic, fine- to coarse-grained, no hydrocarbon odor (HCO), no hydrocarbon staining (HCS)	0.0			
		B1-5	SW		SAND, well graded, dark brown (10YR3/3), moist, non-plastic, fine- to coarse-grained, trace gravel and clay, no HCO, no HCS	0.0			
		B1-10	SW		SAND, well graded, dark brown (10YR3/3), moist, non-plastic, fine- to coarse-grained, no HCO, no HCS	0.0

10.5					Boring terminated at 10.5 feet bgs. No groundwater encountered. Tubing removed upon completion of soil-gas sampling.

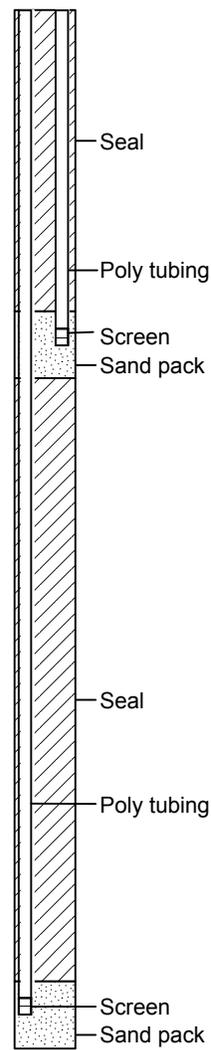
Depth in Feet	Surface Elevation	Sample Identification Number	USCS	GRAPHIC	Sample Condition	OVA/PID READING (ppm)	Sample Condition	Blow Count Recovery Interval	Well: B1b TOC Elev.:
					<input type="checkbox"/> Disturbed <input type="checkbox"/> Continuous Core (undisturbed) <input type="checkbox"/> No Recovery				
0			SW		Grass surface. Hand-augered to 4 feet below ground surface (bgs).				
		B1-3	SW		SAND, well graded, dark brown (10YR3/3), moist, non-plastic, fine- to coarse-grained, no hydrocarbon odor (HCO), no hydrocarbon staining (HCS)	0.0			
		B1-5	SW		SAND, well graded, dark brown (10YR3/3), moist, non-plastic, fine- to coarse-grained, trace gravel and clay, no HCO, no HCS	0.0			
		B1-10	SW		SAND, well graded, dark brown (10YR3/3), moist, non-plastic, fine- to coarse-grained, no HCO, no HCS	0.0			
			SW		SAND, well graded, dark brown (10YR3/3), moist, non-plastic, fine- to coarse-grained, no HCO, no HCS

15					Boring terminated at 15.5 feet bgs. No groundwater encountered. Second boring completed adjacent to original B1 boring to install soil gas probe at 15 feet bgs. Tubing removed upon completion of soil-gas sampling.				
20

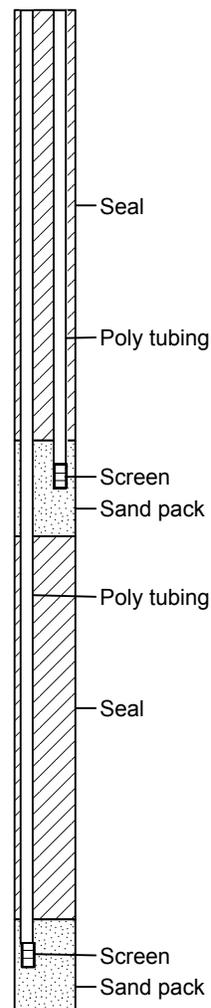
Depth in Feet	Surface Elevation	Sample Identification Number	USCS	GRAPHIC	Sample Condition	OVA/PID READING (ppm)	Sample Condition	Blow Count Recovery Interval	Well: B2 TOC Elev.:
					<input type="checkbox"/> Disturbed <input type="checkbox"/> Continuous Core (undisturbed) <input type="checkbox"/> No Recovery				
0			SW		Grass surface. Hand-augered to 4 feet below ground surface (bgs).				
		B2-3	SW		SAND, well graded, dark brown (10YR3/3), moist, non-plastic, fine- to coarse-grained, no hydrocarbon odor (HCO), no hydrocarbon staining (HCS)	0.0			
5			SW		SAND, well graded, dark brown (10YR3/3), moist, non-plastic, fine- to coarse-grained, trace coarse and clay, no HCO, no HCS	0.0			
10		B2-10	SW		SAND, well graded, dark brown (10YR3/3), moist, non-plastic, fine- to coarse-grained, no HCO, no HCS	0.0			
Boring terminated at 10.5 feet bgs. No groundwater encountered. Tubing removed upon completion of soil-gas sampling.

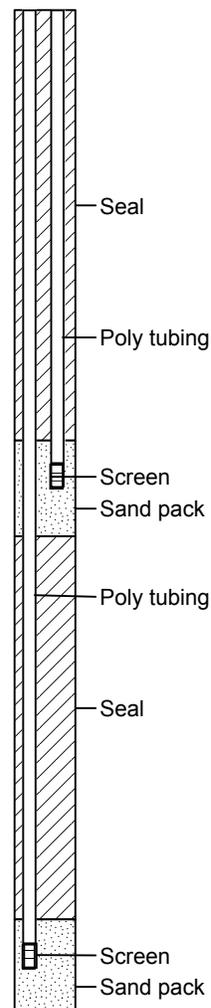
Depth in Feet	Surface Elevation	Sample Identification Number	USCS	GRAPHIC	DESCRIPTION	OVA/PID READING (ppm)	Sample Condition	Blow Count	Recovery Interval	Well: B3 TOC Elev.:
0			SW		Grass surface. Hand-augered to 4 feet below ground surface (bgs).					
		B3-2				0.0				
		B3-3	SW		SAND, well graded, dark brown (10YR3/3), moist, non-plastic, fine- to coarse-grained, no hydrocarbon odor (HCO), no hydrocarbon staining (HCS)					
		B3-5								
5			SW		SAND, well graded, dark brown (10YR3/3), moist, non-plastic, fine- to coarse-grained, no HCO, no HCS	0.1				
		B3-10	SW		SAND, well graded, dark brown (10YR3/3), moist, non-plastic, fine- to coarse-grained, clay content increases with depth, no HCO, no HCS	0.7				
10										
Boring terminated at 10.5 feet bgs. No groundwater encountered. Tubing removed upon completion of soil-gas sampling.

No hydrocarbon odors were observed in any of the samples collected from the borings. PID readings greater than 0.0 were measured in samples collected from borings B3 and B4 and ranged from 0.1 to 0.7 ppm. PID measurements are recorded on the boring logs in Appendix B. Groundwater was not encountered in and of the borings. No organic or artificial debris was encountered in the soil recovered from the borings. Thorough

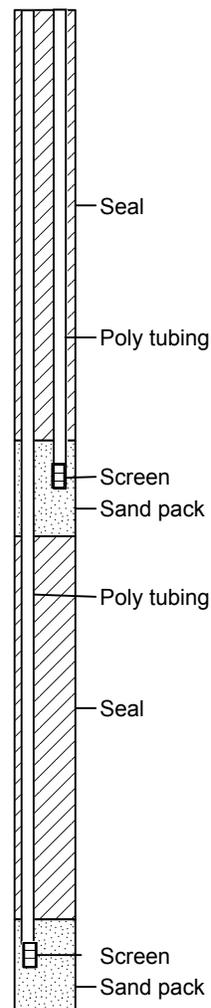
Depth in Feet	Surface Elevation	Sample Identification Number	USCS	GRAPHIC	DESCRIPTION	OVA/PID READING (ppm)	Sample Condition	Blow Count Recovery Interval	Well: B4 TOC Elev.:
0			SW		Grass surface. Hand-augered to 4 feet below ground surface (bgs).				
		B4-2				0.0			
			SW		SAND, well graded, dark brown (10YR3/3), moist, non-plastic, fine- to coarse-grained, no hydrocarbon odor (HCO), no hydrocarbon staining (HCS)				
		B4-3							
		B4-5				0.2			
			SW		SAND, well graded, dark brown (10YR3/3), moist, non-plastic, fine- to coarse-grained, no HCO, no HCS				
		B4-10				0.1			
			SW		SAND, well graded, dark brown (10YR3/3), moist, non-plastic, fine- to coarse-grained, clay content increases with depth, no HCO, no HCS				
<p>Boring terminated at 10.5 feet bgs.</p> <p>No groundwater encountered.</p> <p>Tubing removed upon completion of soil-gas sampling.</p>

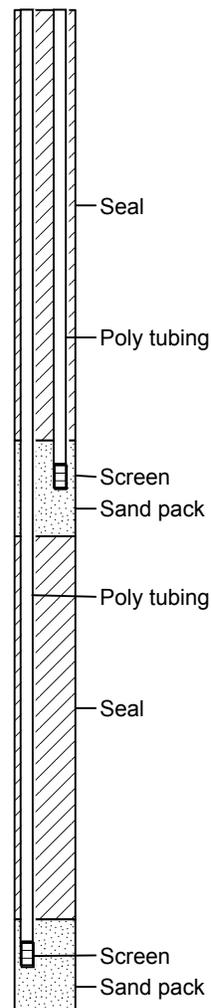
Depth in Feet	Surface Elevation	Sample Identification Number	USCS	GRAPHIC	Sample Condition	OVA/PID READING (ppm)	Sample Condition	Blow Count Recovery Interval	Well: B5 TOC Elev.:
					<input type="checkbox"/> Disturbed <input type="checkbox"/> Continuous Core (undisturbed) <input type="checkbox"/> No Recovery				
0			SW		Grass surface. Hand-augered to 4 feet below ground surface (bgs).				
		B5-2	SW		SAND, well graded, brown (10YR4/3), moist, non-plastic, fine- to coarse-grained, no hydrocarbon odor (HCO), no hydrocarbon staining (HCS)	0.0			
		B5-3							
		B5-3.5							
		B5-5	SP		SAND, poorly graded, dark gray (10YR4/1), slightly moist, non-plastic, medium-grained, no HCO, no HCS	0.0			
			SW		SAND, well graded, brown (10YR3/3), moist, non-plastic, fine- to coarse-grained, trace clay, no HCO, no HCS	0.0			
		B5-10	SW		SAND, well graded, brown (10YR3/3), moist, non-plastic, fine- to coarse-grained, trace clay, no HCO, no HCS	0.0

Boring terminated at 10.5 feet bgs. No groundwater encountered. Tubing removed upon completion of soil-gas sampling.
