**FIGURE 5-1
LAYOUT OF THE FORMER
WASTEWATER TREATMENT SYSTEMS**
RCRA FACILITY INVESTIGATION/REMEDIAL
INVESTIGATION REPORT (VOLUME 1)
PG&E TOPOCK COMPRESSOR STATION
NEEDLES, CALIFORNIA

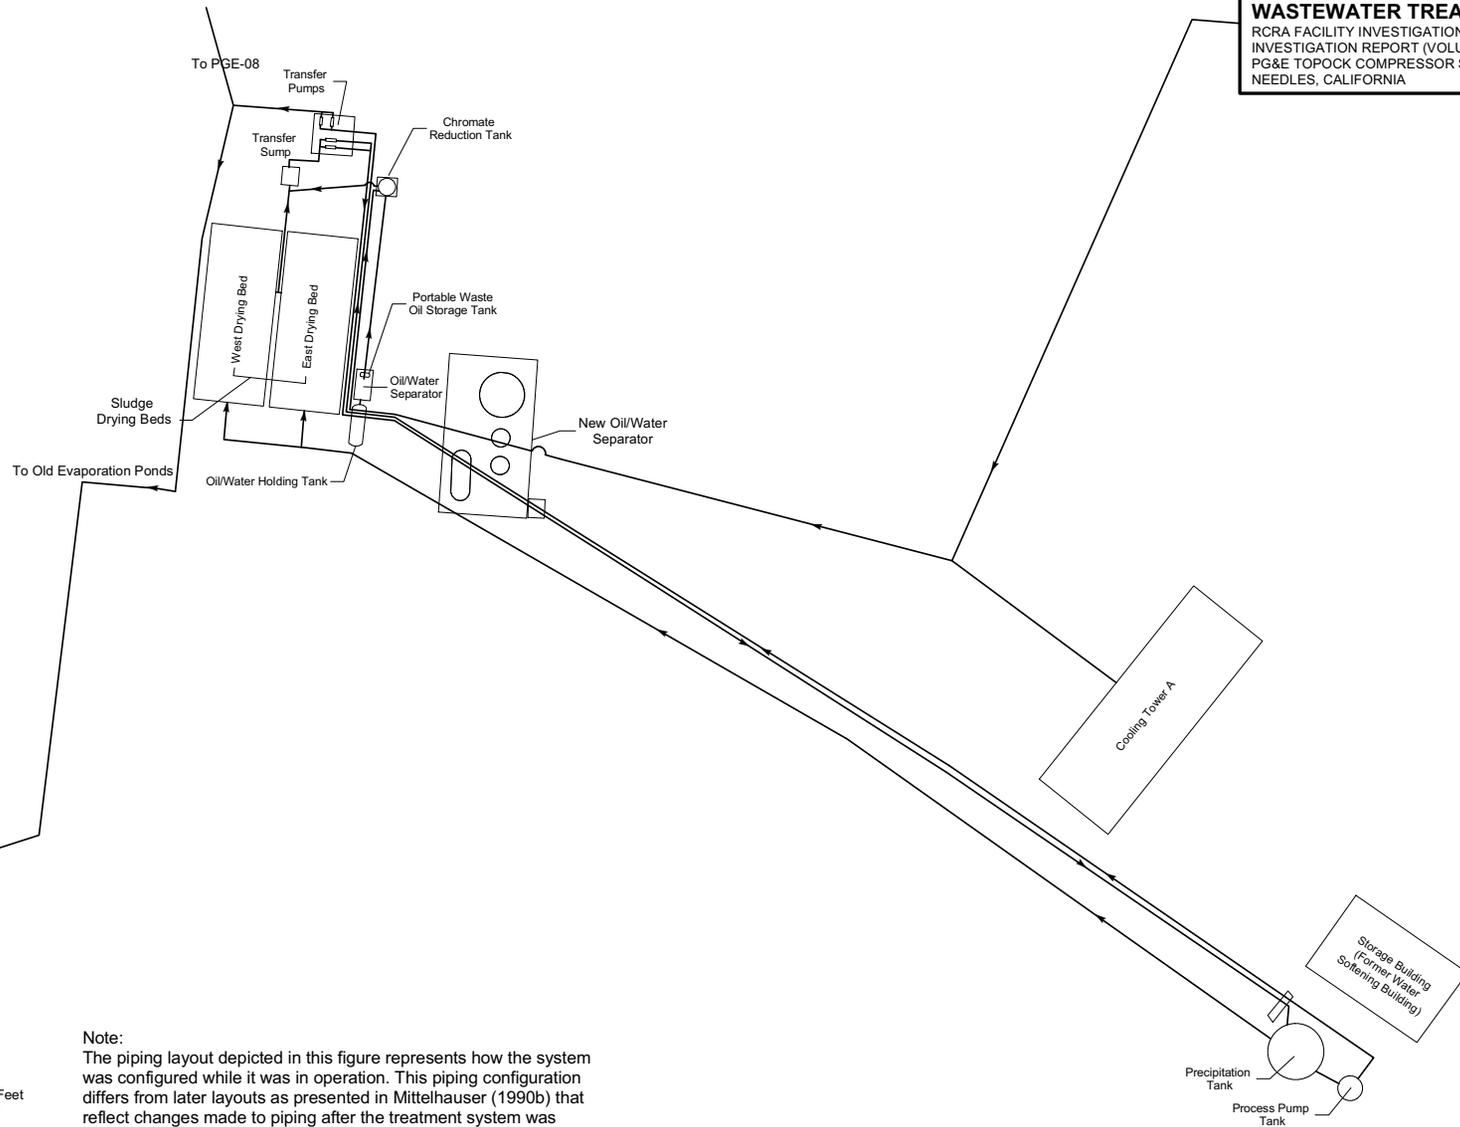
Note:
The piping layout depicted in this figure represents how the system was configured while it was in operation. This piping configuration differs from later layouts as presented in Mittelhauser (1990b) that reflect changes made to piping after the treatment system was removed from service. All piping locations are approximate.

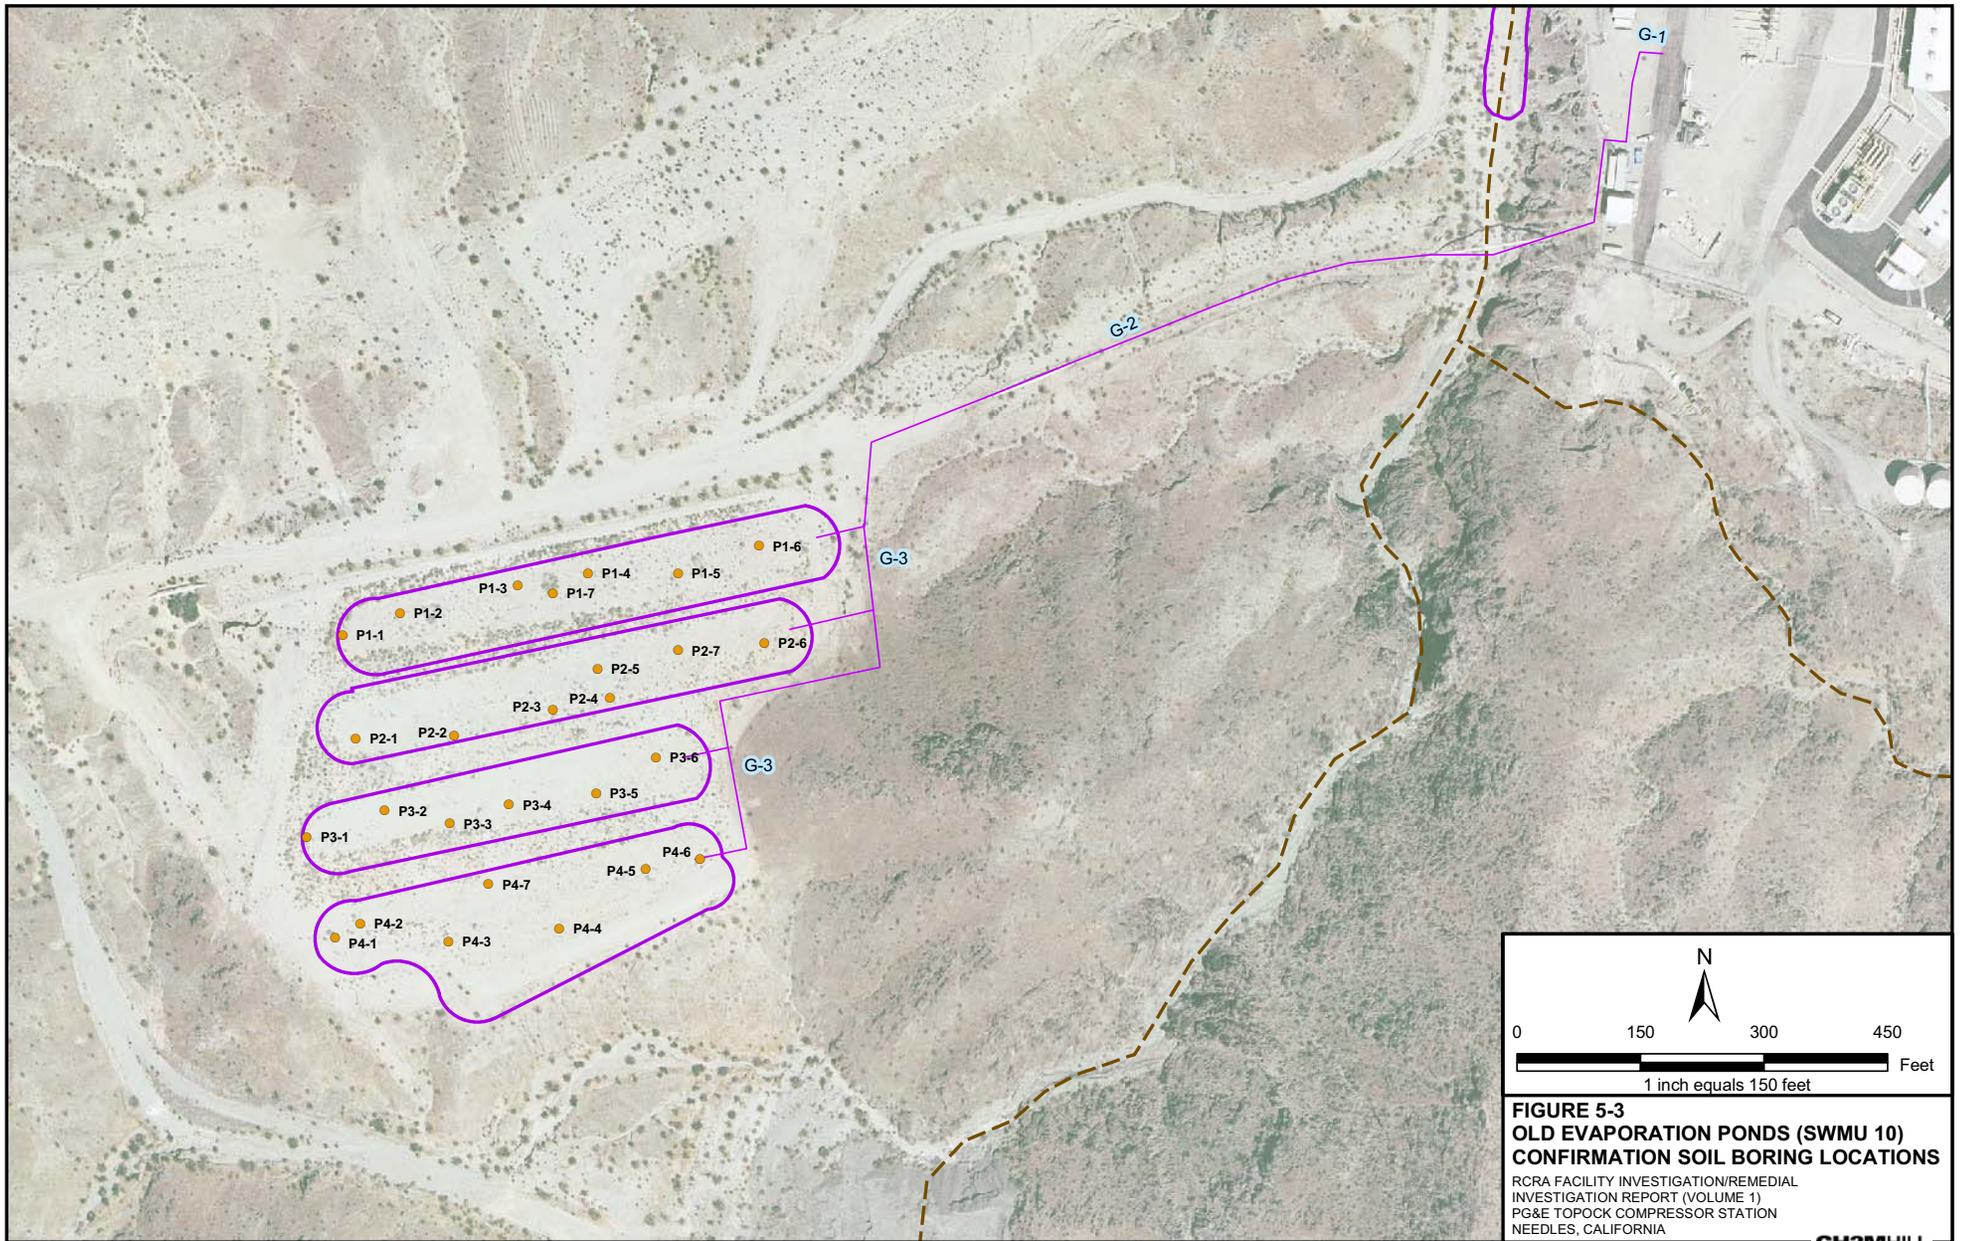
FIGURE 5-3
OLD EVAPORATION PONDS (SWMU 10)
CONFIRMATION SOIL BORING LOCATIONS
 RCRA FACILITY INVESTIGATION/REMEDIAL
 INVESTIGATION REPORT (VOLUME 1)
 PG&E TOPECO COMPRESSOR STATION
 NEEDLES, CALIFORNIA

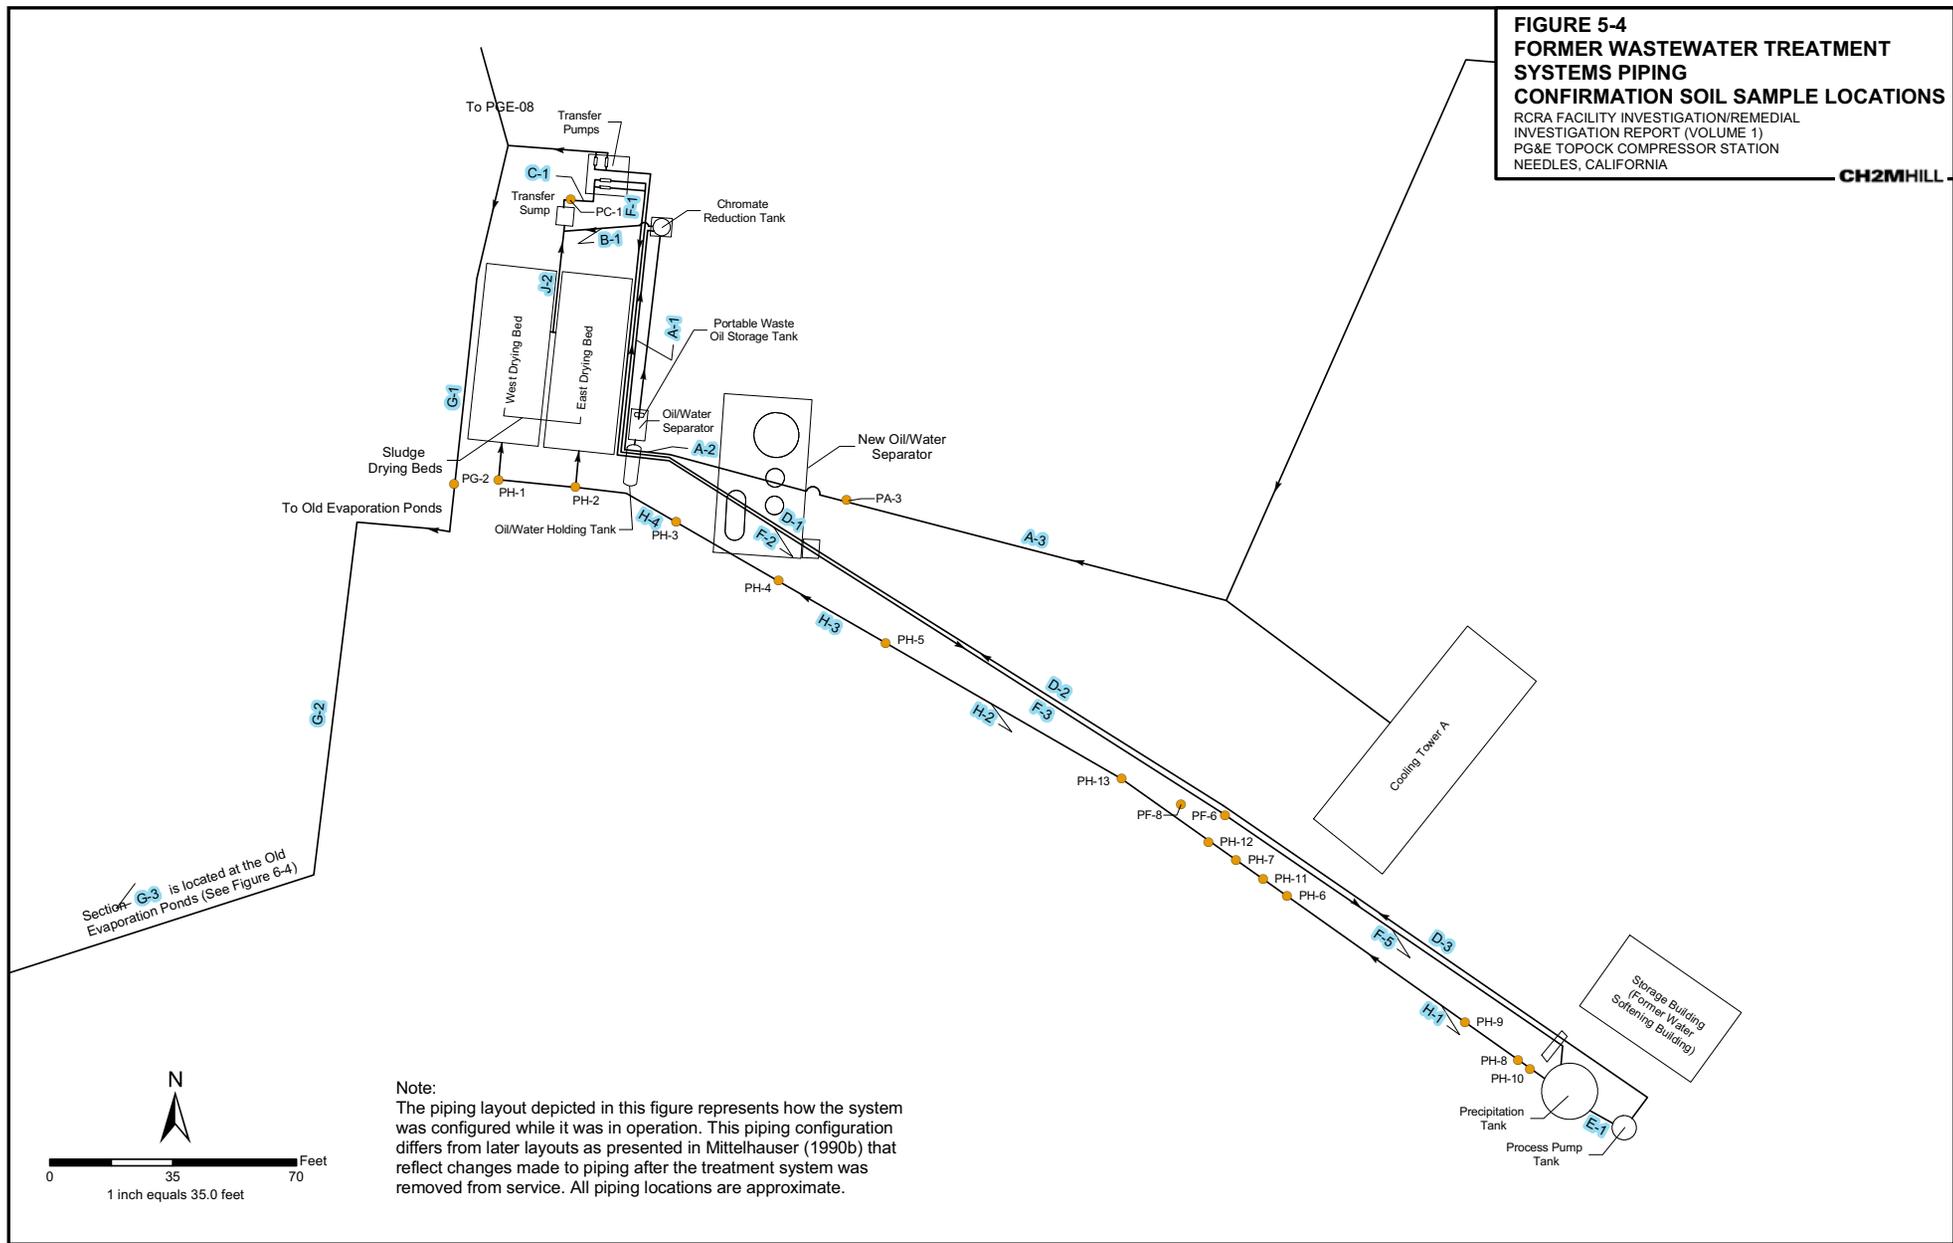
**FIGURE 5-4
FORMER WASTEWATER TREATMENT
SYSTEMS PIPING
CONFIRMATION SOIL SAMPLE LOCATIONS**
RCRA FACILITY INVESTIGATION/REMEDIAL
INVESTIGATION REPORT (VOLUME 1)
PG&E TOPOCK COMPRESSOR STATION
NEEDLES, CALIFORNIA
CH2MHILL

Note:
The piping layout depicted in this figure represents how the system was configured while it was in operation. This piping configuration differs from later layouts as presented in Mittelhauser (1990b) that reflect changes made to piping after the treatment system was removed from service. All piping locations are approximate.
