Analysis of 6PPD-quinone in a Variety of Matrices

California DTSC, July 29th 2021

Eurofins Environment
Testing America, West Sacramento

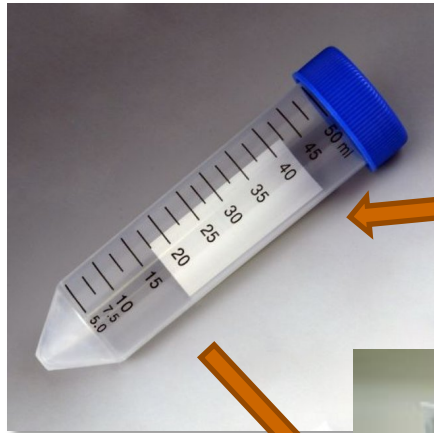
Stable isotope of 6PPD-quinone

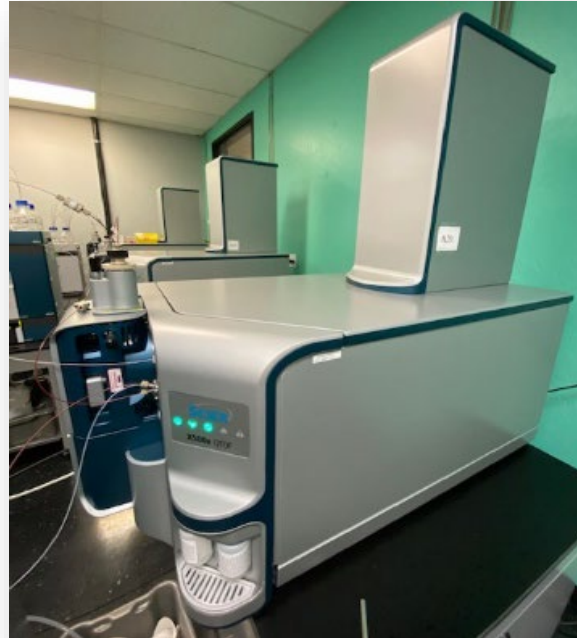
Why use a QTOF?

- In general: As resolution increases, false positives decrease
- Instrument measures the Time-of-Flight of compounds and precisely determines mass
- Exact mass data can be gathered on the parent compound or unique fragments of it
- Possible to move to an MS/MS after careful observation

High-resolution data add confidence by mitigating the potential for interferences

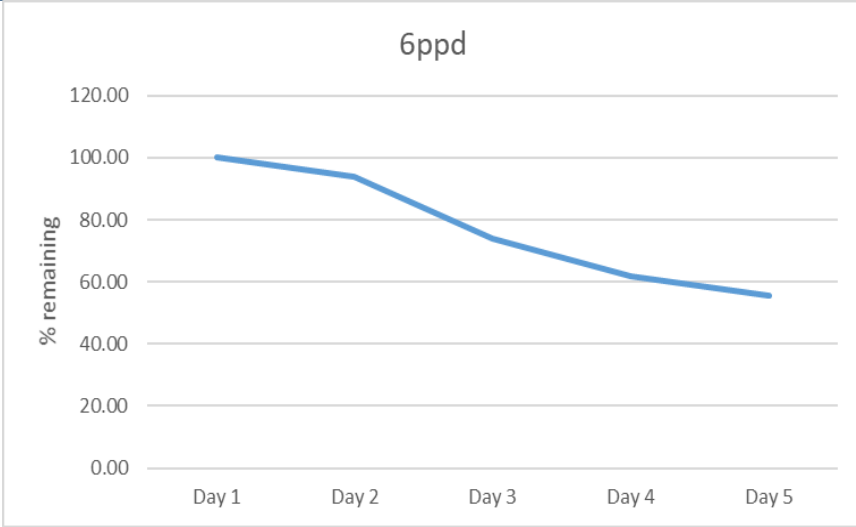
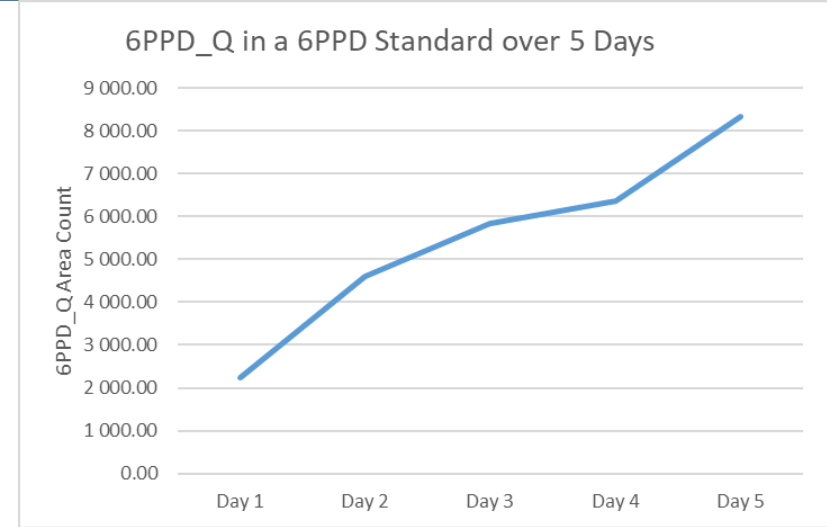
Parent Compound (6PPD) Instability

- 6PPD Standard in Methanol, in the dark, at 4C.
- New vials injected each day

- Purging with Nitrogen did not slow degradation
- pH changes did not slow degradation

Quantitation of parent compound, 6PPD, unreliable and indefensible

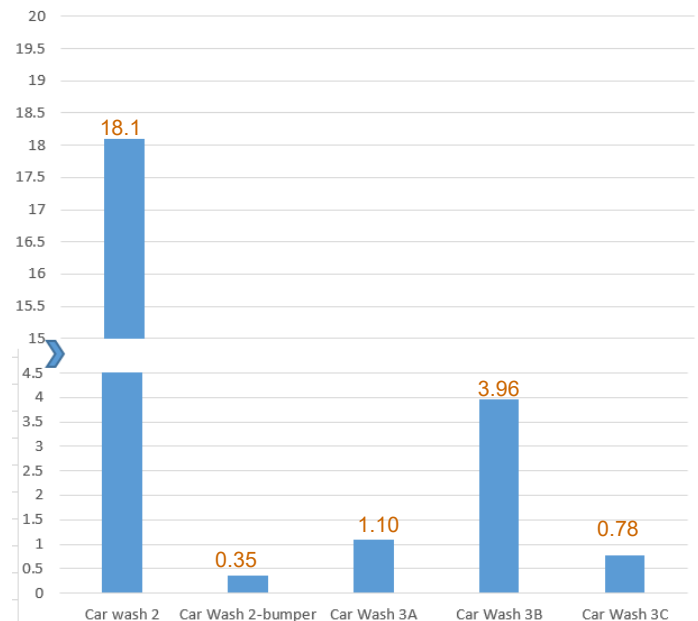
Additional Car Washes, ug/L (ppb)

- HDPE bottles taped to bumper
- Containers open for the entire car wash
- Importance of isotope dilution

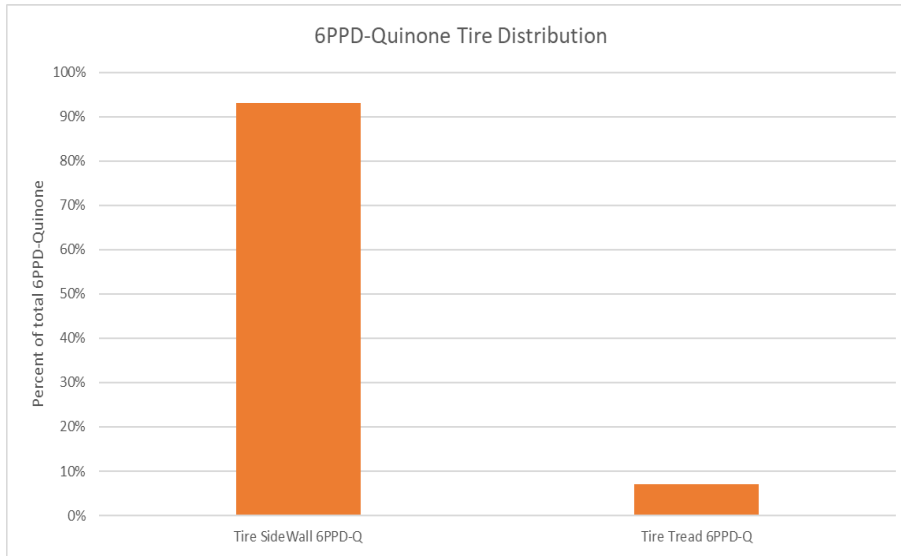
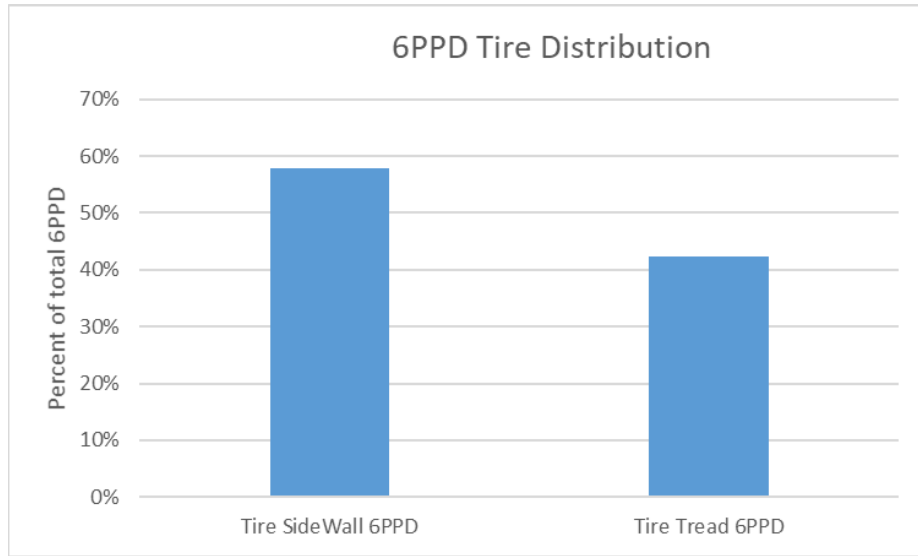
Tire Distribution of 6PPD-Quinone

- 6PPD sidewall and tread distribution does not match 6PPD-Quinone distribution.

- Tire was not mounted on a vehicle
- Tire had ~50% of life left on tread

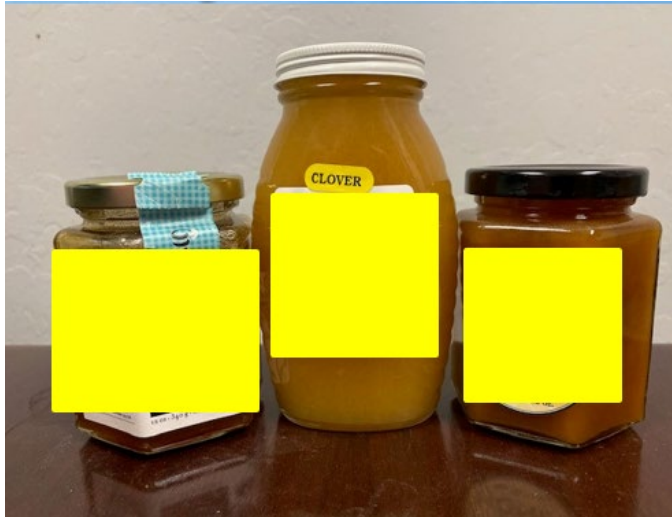
Honey: Method Performance Test

- All three honey samples: **Non-Detect**
- Reporting Limit = 0.25 ng/g (ppb)
- Average Internal standard recovery: 73%

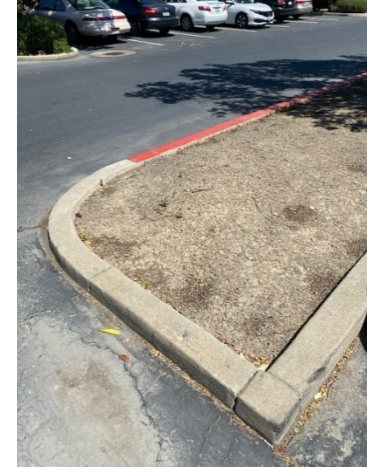
Planter Box Detection

- 5ng/g (ppb) 6PPD-Q in planter box soil
- Non-detect for 6PPD (Monitored, but not quantitated)
- What is the mechanism for deposition in the planter box?
 - Splashing from rain/sprinklers?
 - Tire wear particles?
 - Atmospheric deposition?
