DTSC Final Summary Report of Woolsey Fire

Impacts at SSFL & Surrounding Communities Sampling Results

December 2020

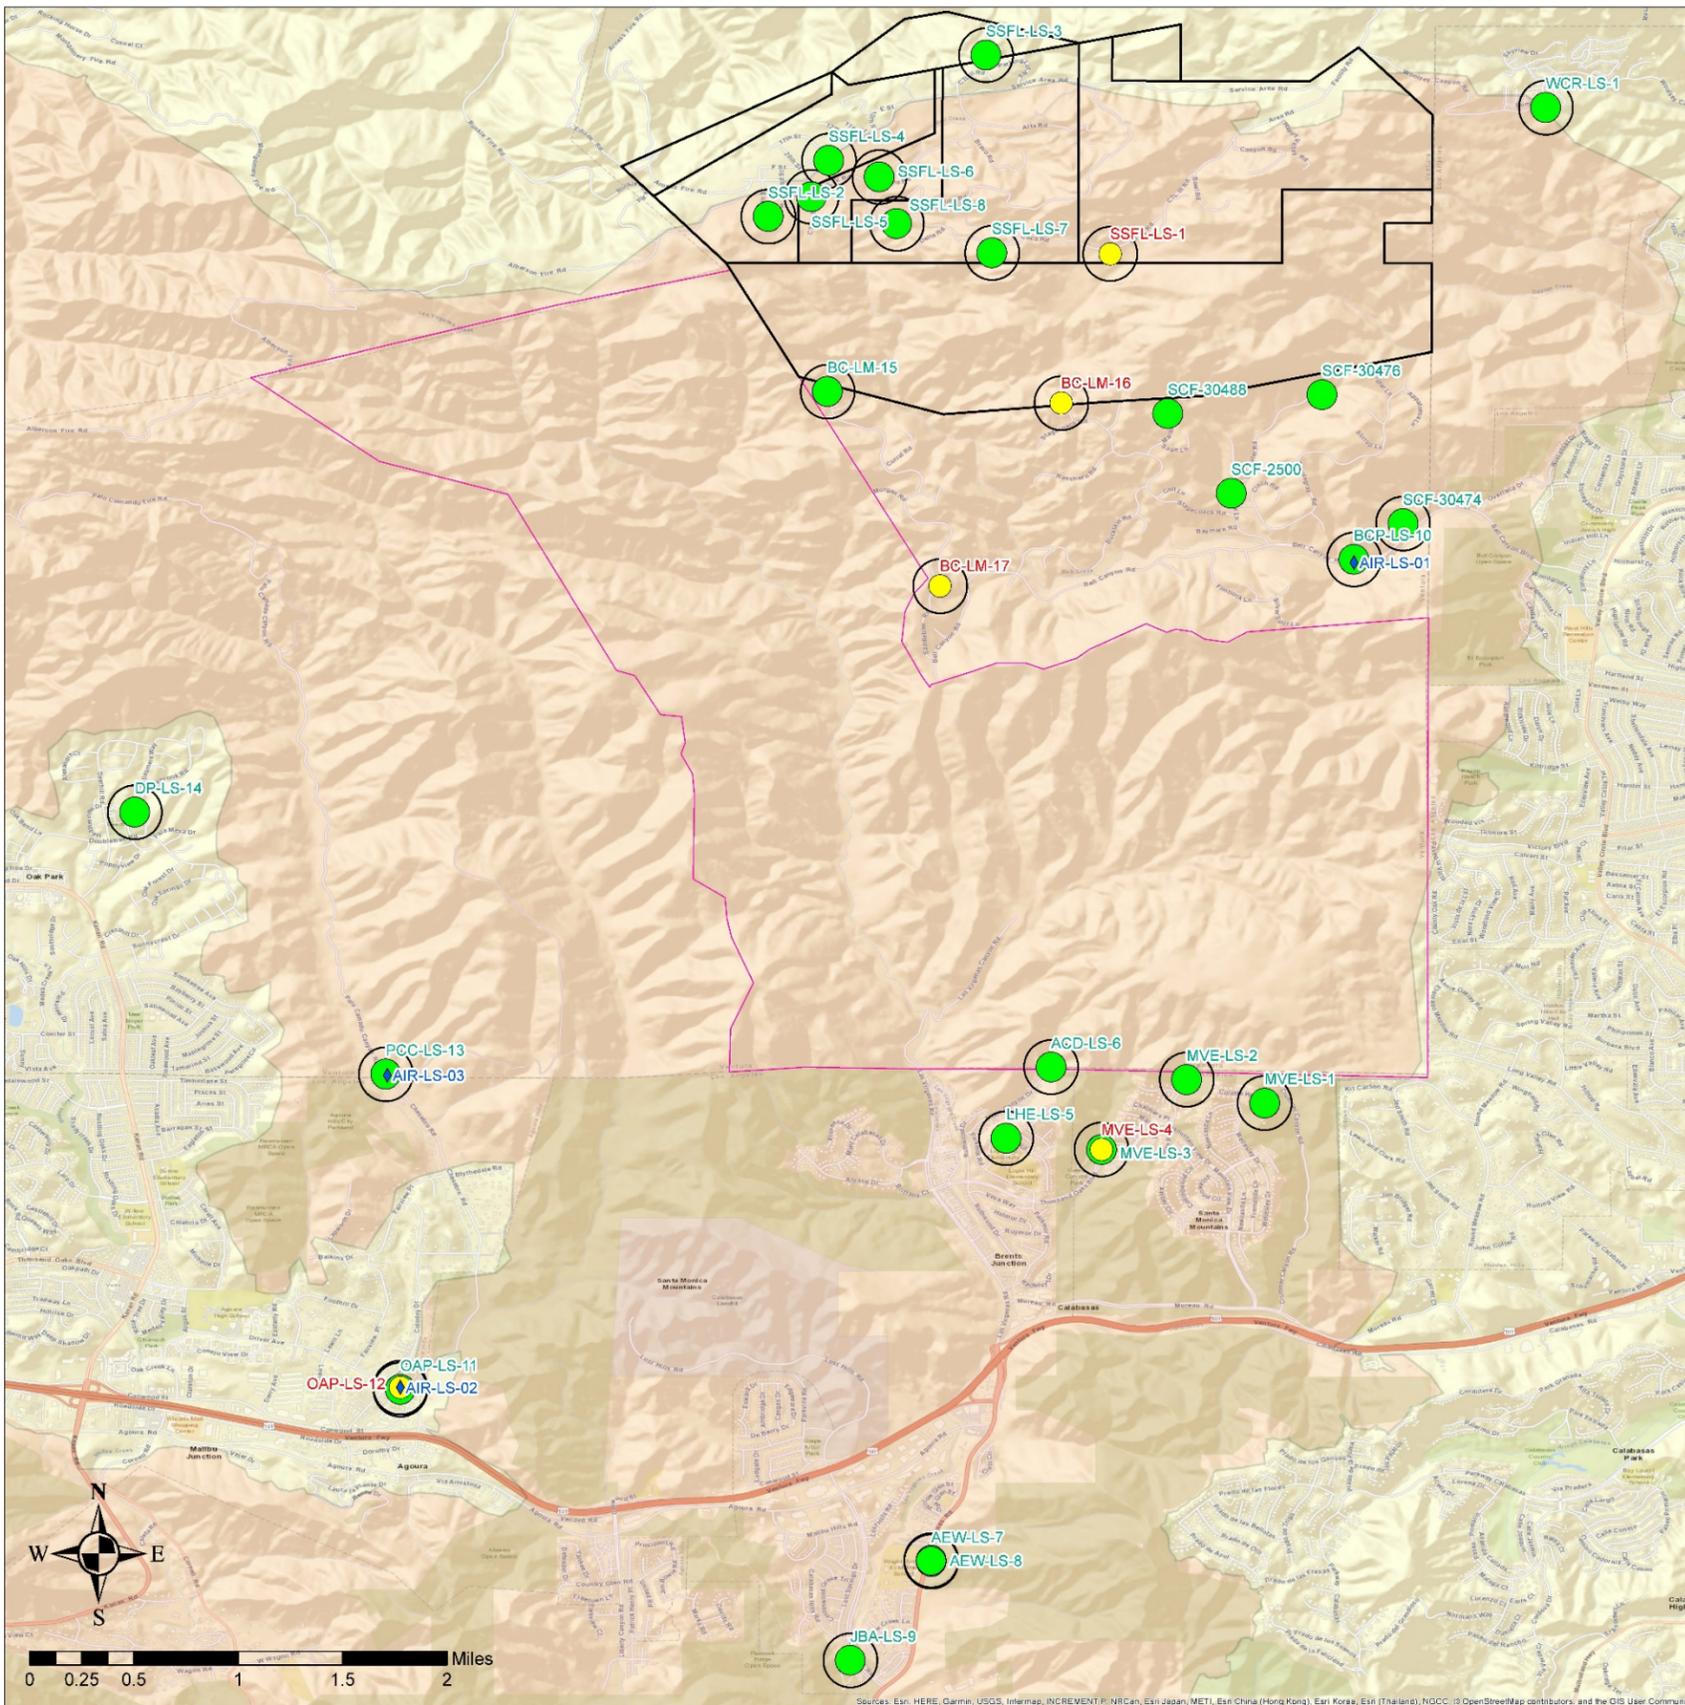
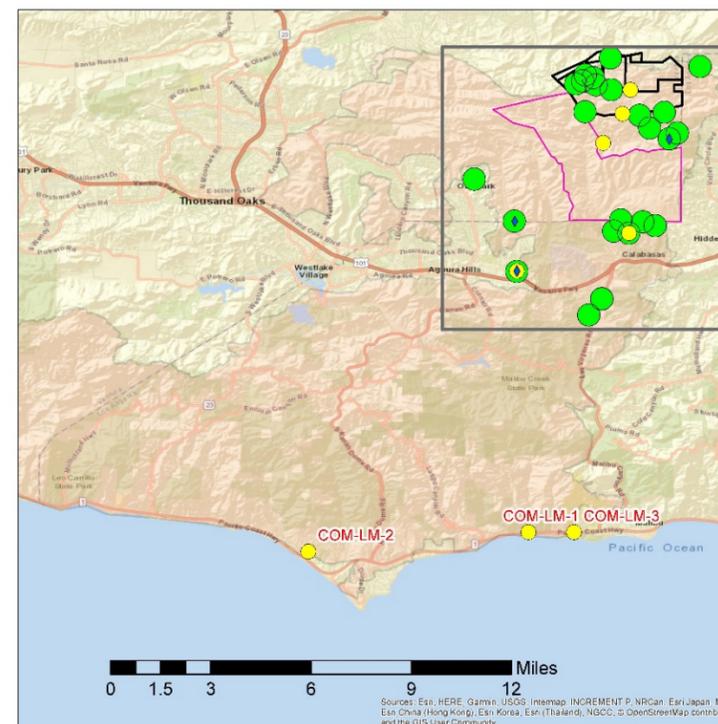
MEASUREMENT LOCATIONS DTSC Soil, Ash and Air Sampling

DTSC took samples at SSFL and in other areas off site to ensure wide coverage of nearby residential communities. Sample locations are shown on Figure 2, and sample information is presented in Table A-1 (Appendix A). The DOE RAP team and 9th CST collected field measurements and conducted sampling for radionuclides and chemicals, respectively, at locations co-located with DTSC sampling efforts. Table A-2 (Appendix A) presents a summary of the locations where sampling was conducted by DTSC, DOE RAP, and the 9th CST at the same location.

DTSC scientists and investigators also took real-time measurements for radiation and hazardous materials, and collected soil, ash, and air samples from November 11 to November 14, 2018. The field measurements and sampling occurred on SSFL and off site in the surrounding and downwind communities of Woolsey Canyon, Bell Canyon, Calabasas, Oak Park, Agoura Hills, and Malibu. Sample locations were selected based on a variety of factors, including modeling, proximity of residential areas to SSFL and the ability to access the areas. The name, location, and type of the 36 samples collected are presented in Table A-1. DTSC, DOE RAP and the 9th CST collected a number of samples at the same locations. Table A-2 presents a list of co-located samples. The sample locations are shown on Figure 2.
