BKK Sanitary Landfill

SUCCESS STORY, June 2006

BKK Sanitary Landfill Storm Drain Repair Project

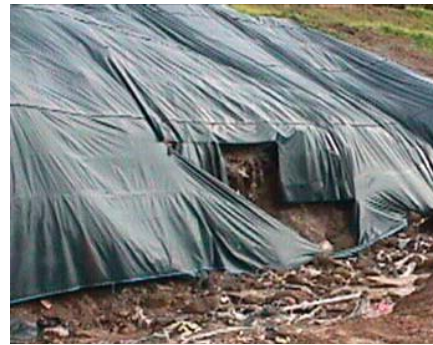
Storm drain failure

Storm drain repair work was initiated in FY 2004/05 with plans developed to replace a 3,000 foot section of 48" diameter line, 500 feet of 72" diameter line, and 1,260 feet of 84" diameter line. Work on the 84" line was extremely complex due to the fact that 260 feet of the line were demolished by a slope failure and 1,000 feet were between 40 and 50 feet underground. All of the shallow old drain line was excavated and removed and the deeper line was cleaned out to create a tunnel. With this work completed, a new concrete surface

drain was installed to replace the 48" line. The larger diameter lines were replaced with 84" reinforced concrete pipe and 72" and 48" high-density polyethylene pipe. The 48" diameter pipe runs through the 1,000-foot tunnel to connect the line with upper sections of the drain system. All of this work was completed by January of 2006 at a cost of approximately \$4.6 million. A second phase of this project focusing on replacement of an additional 2,500 feet of 24" and 36" drain line, will be completed in FY 2006/07 at a cost of approximately \$1.5 million.

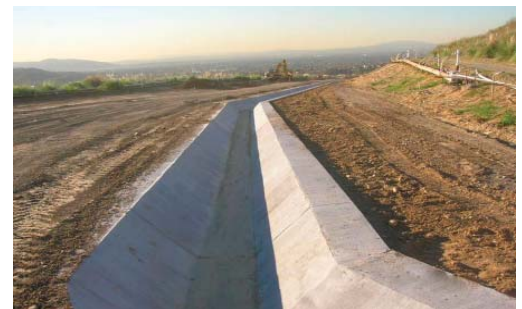
Construction underway
